**SPATIOTEMPORAL ANALYSIS AND
REHABILITATION OF ALLUVIAL GOLD
MINING-AFFECTED AREAS IN BETARÉ-OYA,
CAMEROON (2021-2025) USING REMOTE
SENSING**

A DISSERTATION

Presented to the
Department of Mining Engineering
Program at Selinus University

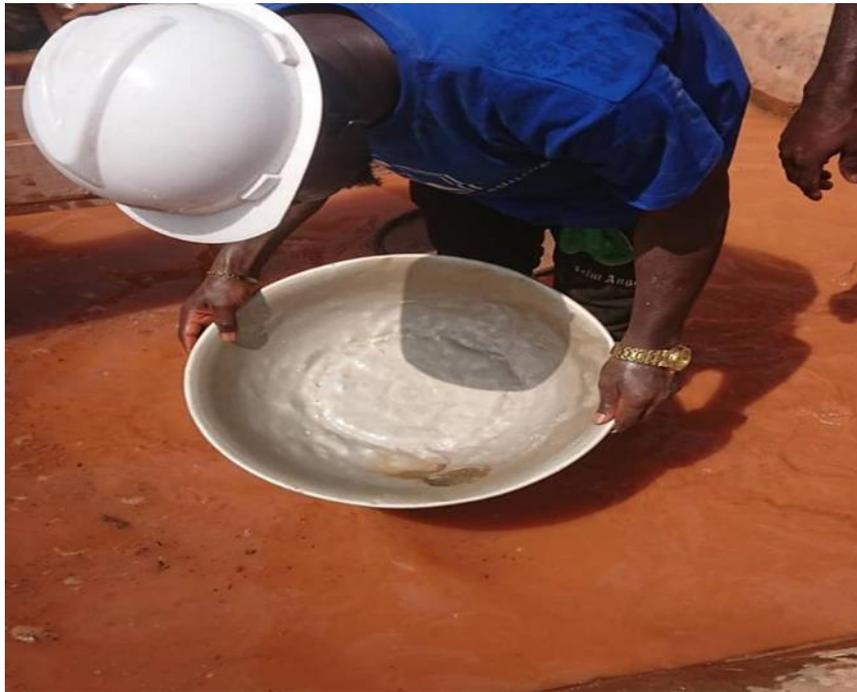
Figure 2.1: Panning Process

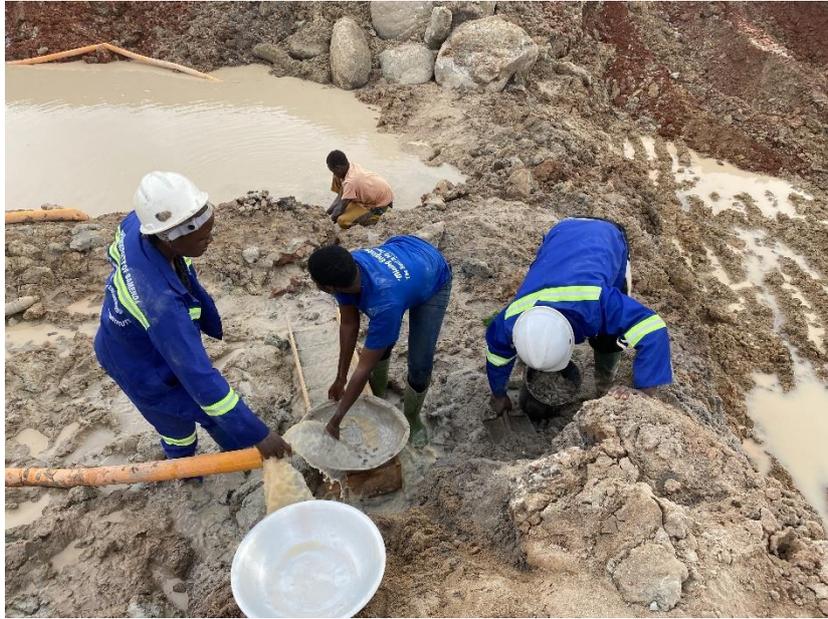
Figure 2.2: Sluicing Process

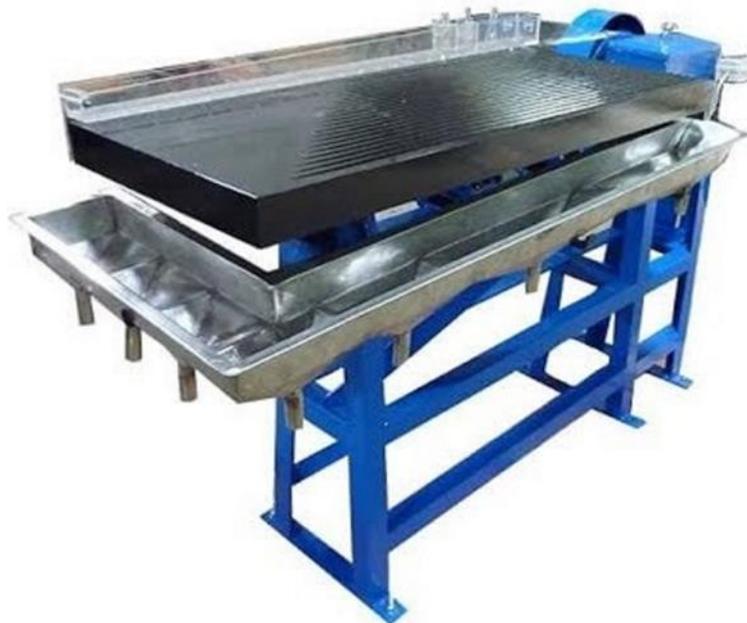
Figure 2.3: Shaking table

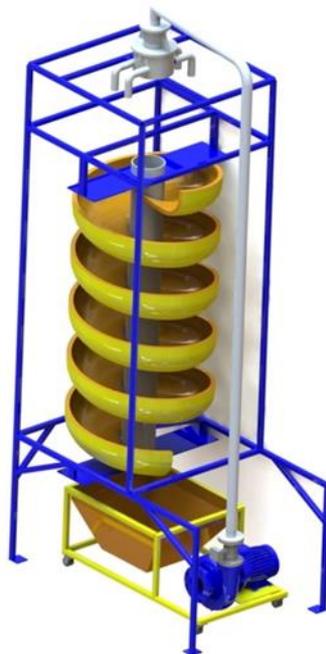
Figure 2.4: Spiral concentrator

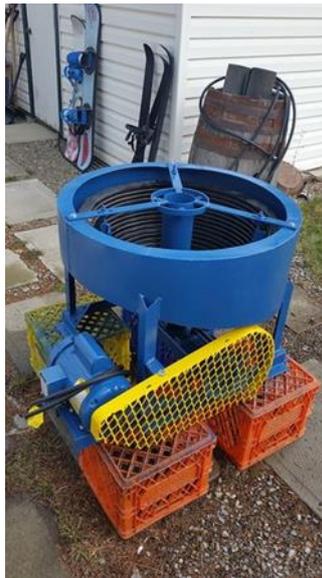
Figure 2.5: Bowl Concentrator

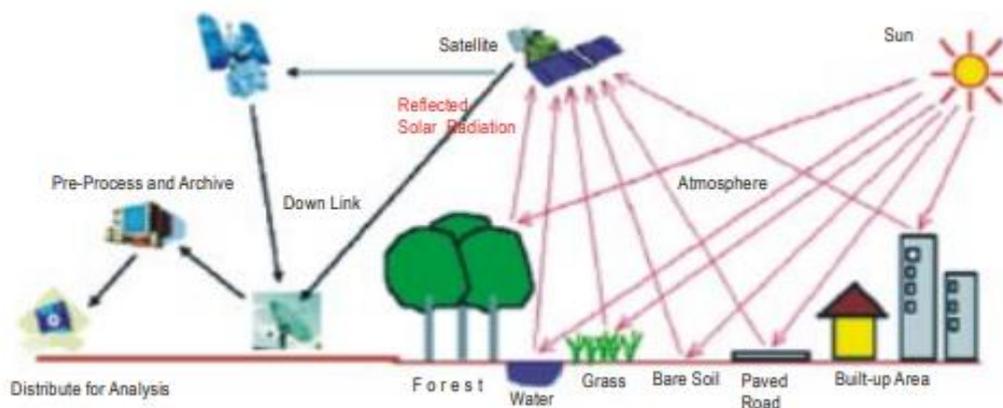
Figure 2.6: Illustration of remote sensing (Aggarwal, 2011)

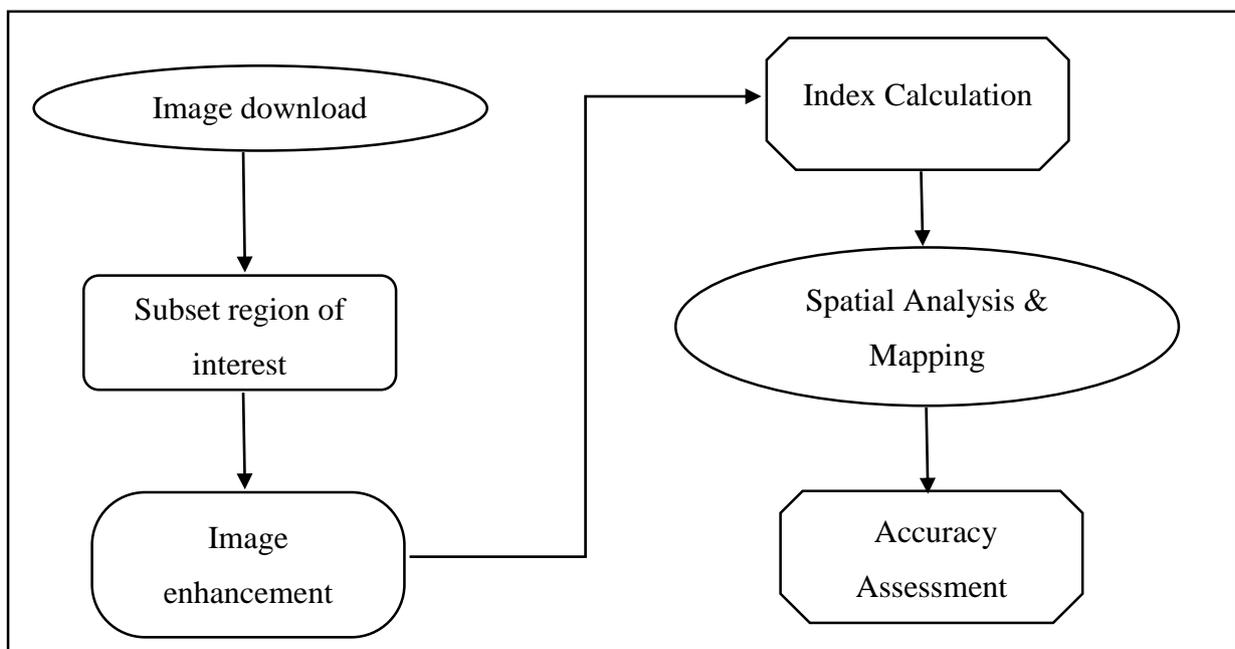
Figure 3.5: Flowchart for BSI, NDMI, NDVI, NDWI, TI and SSC

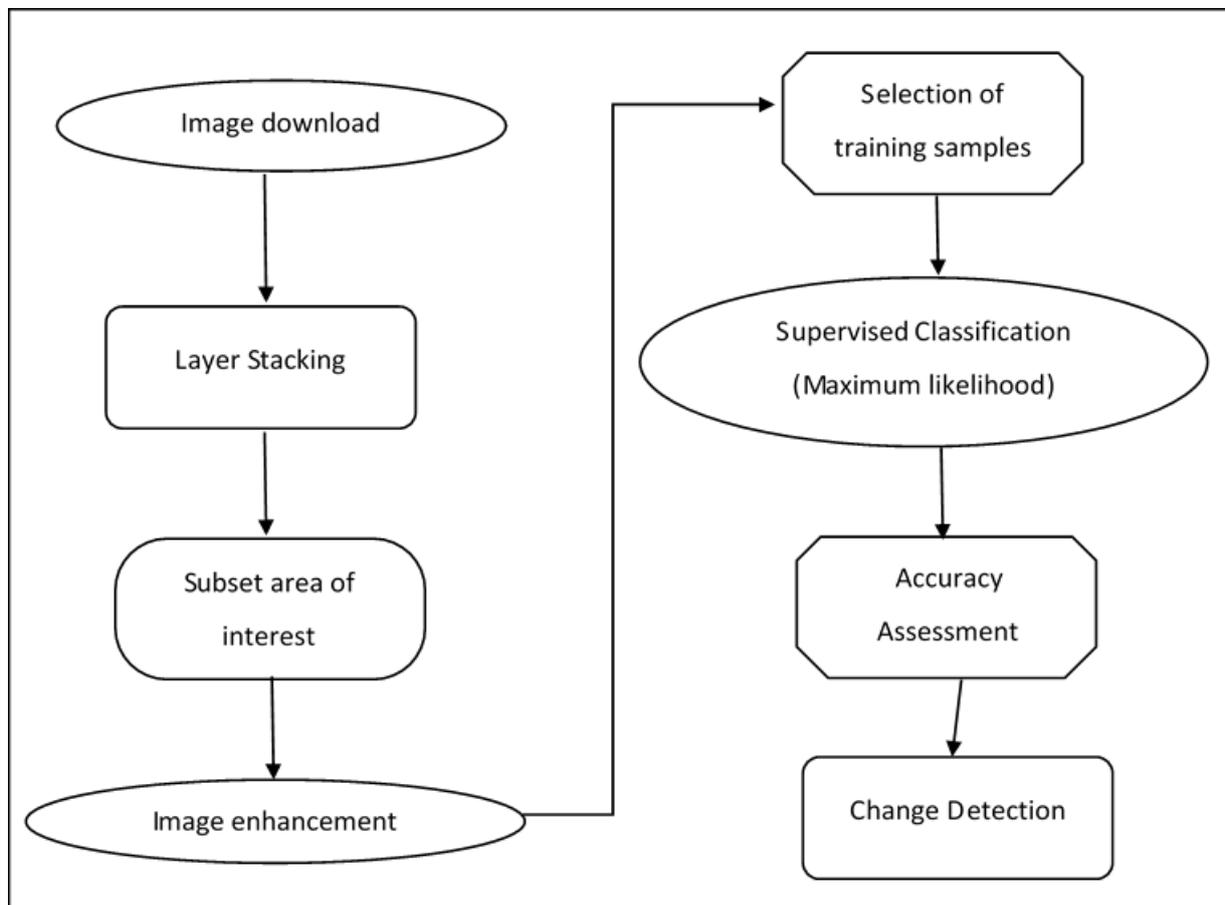
Figure 3.7: Flowchart for LULC

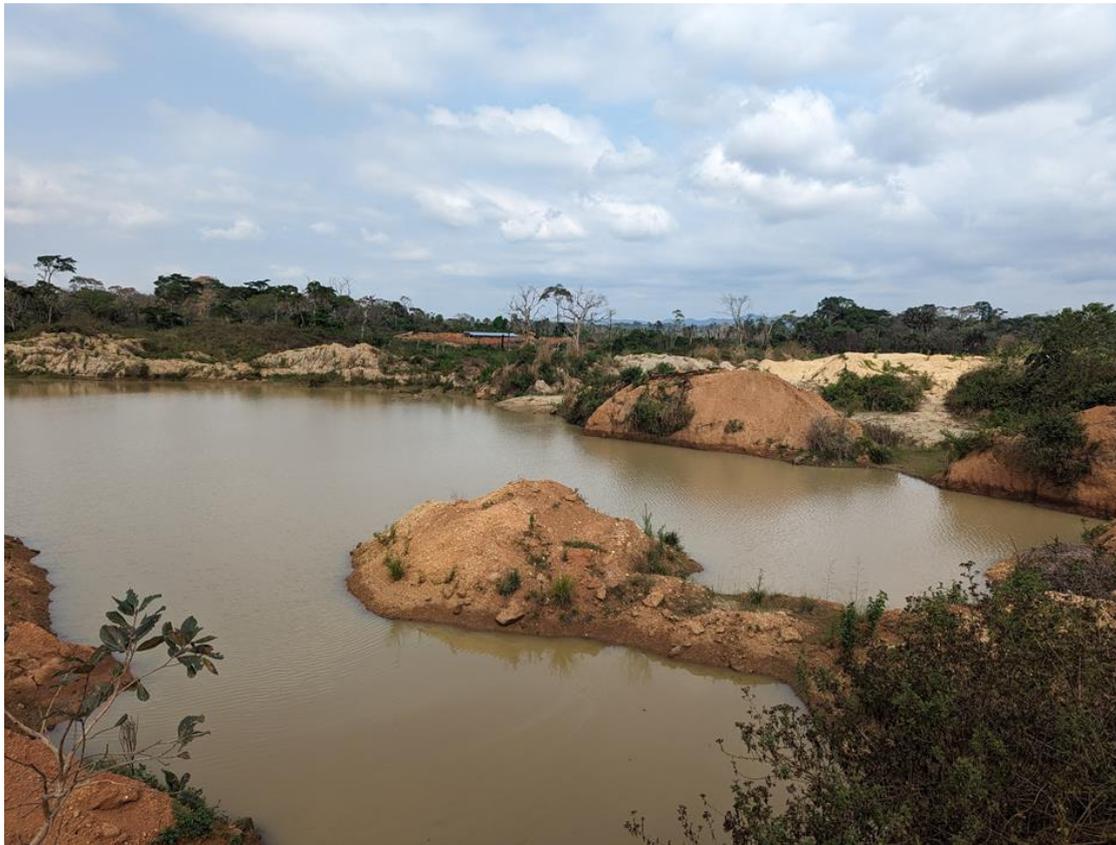
Figure 4.1: Abandoned Mining Pit with Turbid Water (Location: Kombo-koro)

Figure 4.1 shows a photograph taken at a former mining site at kombo-koro, depicting a large, abandoned mining pit filled with turbid, stagnant water. The water's opaque, brownish color suggests a high concentration of suspended sediments and potential chemical contamination, consistent with the findings of Babut et al. (2019), who reported elevated levels of mercury and other heavy metals in water samples from the Betaré-Oya region. The surrounding landscape is devoid of vegetation, with exposed soil and eroded banks clearly visible. This lack of vegetation cover exacerbates soil erosion and hinders natural regeneration, highlighting the long-term environmental consequences of unregulated mining practices, where excavated areas are left unrehabilitated, leading to the accumulation of contaminated water and the loss of biodiversity."

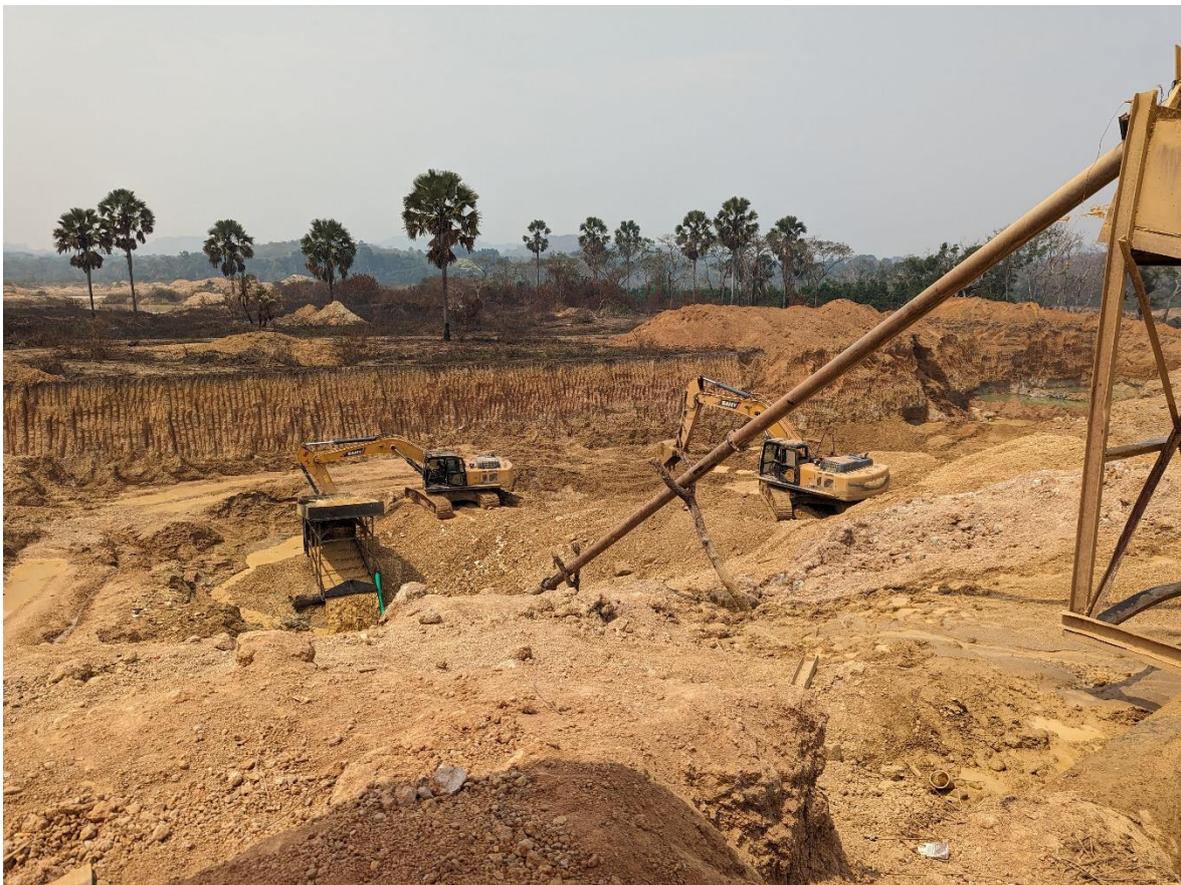
Figure 4.2: Active Mining Site with Heavy Machinery (Location: Timangaro)

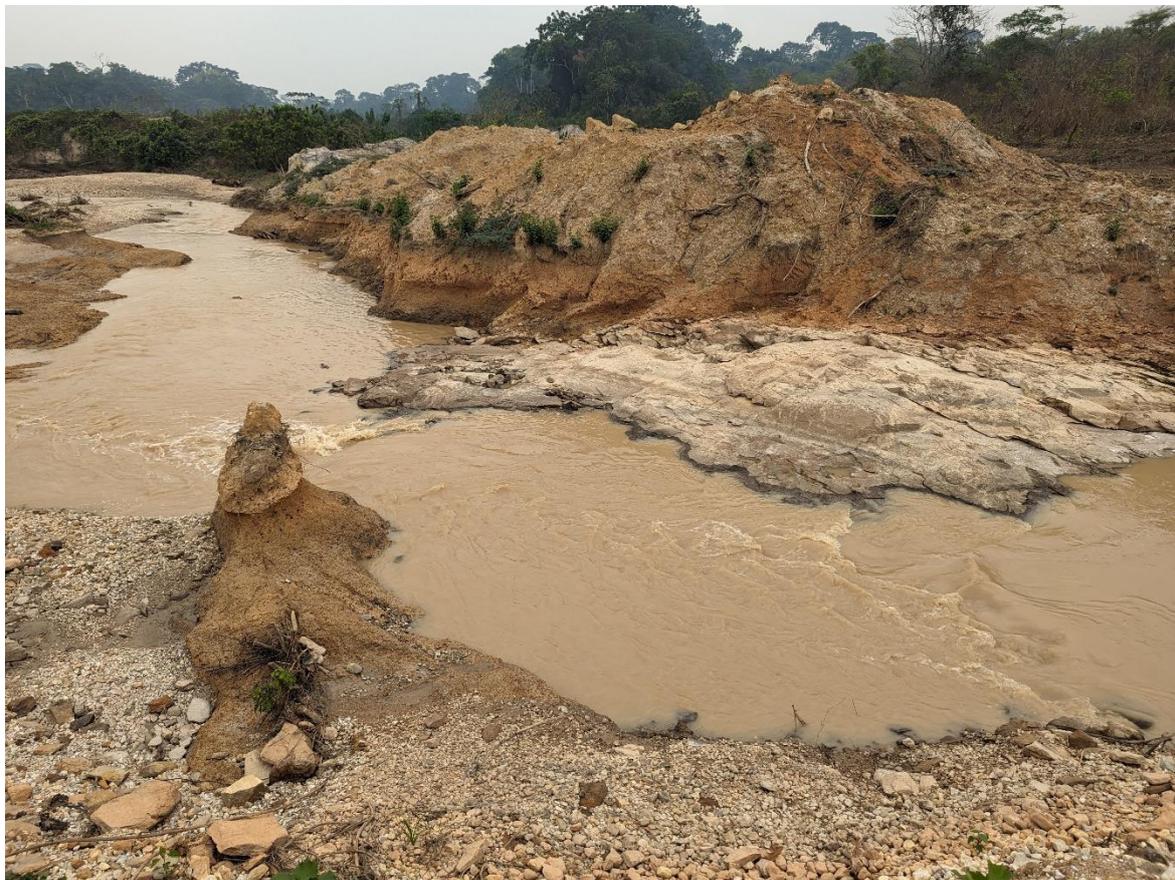
Figure 4.3: Altered River Course and Sediment Deposition (Location: Lom River)

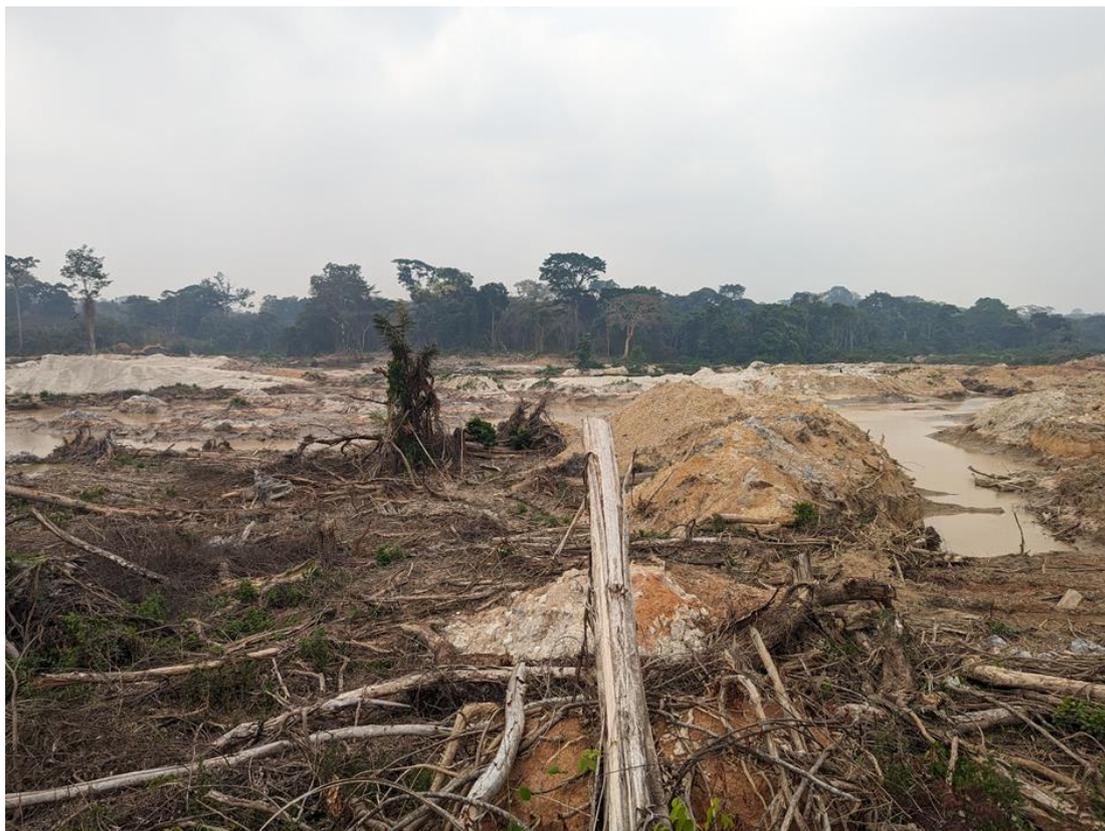
Figure 4.4 shows a barren landscape in an abandoned mining area, characterized by scattered debris, minimal vegetation cover, and compacted soil. The photograph suggests a complete loss of topsoil and a lack of conditions suitable for natural regeneration. This aligns with the findings of D'Souza (2020), who emphasized the severe environmental degradation, including land degradation, deforestation, and biodiversity loss, resulting from artisanal and small-scale mining in Africa."

Figure 4.4: Barren Landscape with Scattered Debris (Location: Nakayo)

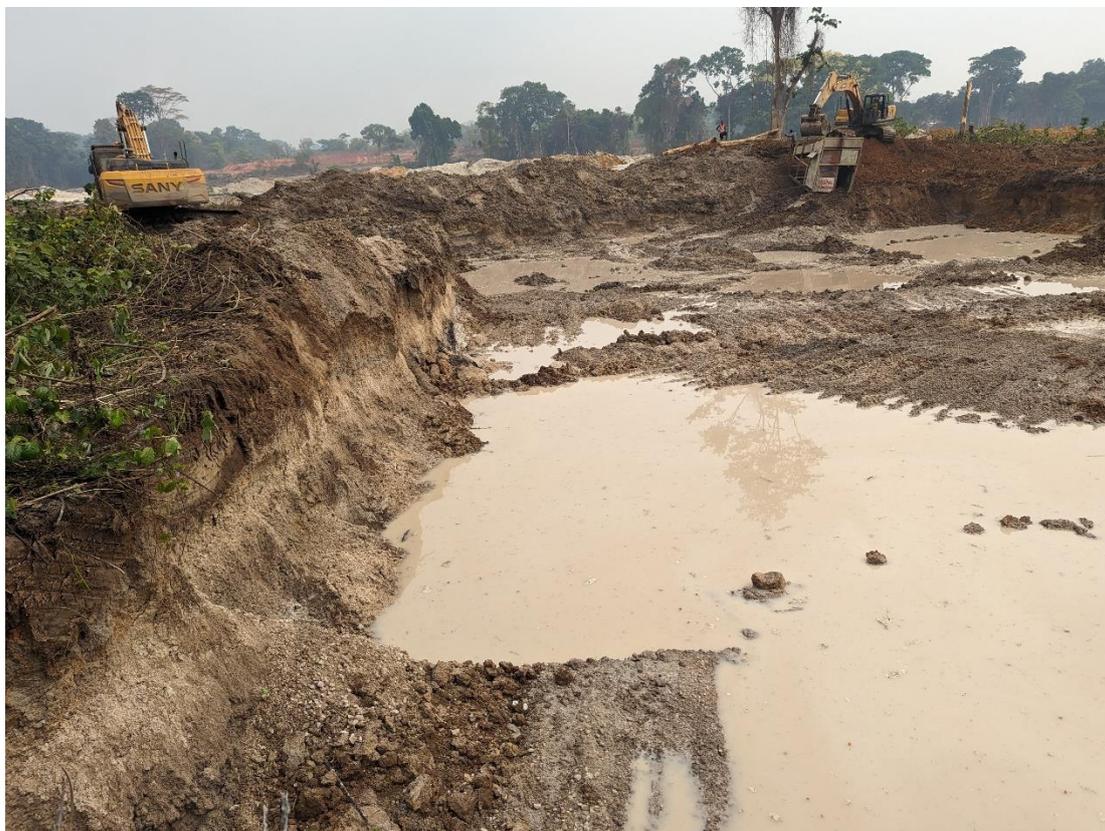
Figure 4.5: Large Excavation Pit with Standing Water (Location: Mali village)

Figure 4.5 shows a large excavation pit filled with standing water, likely rainwater mixed with sediment and potential contaminants. The photograph highlights the scale of disturbance caused by mining activities and the lack of rehabilitation efforts to restore the landscape. The standing water can serve as a breeding ground for mosquitoes and other disease vectors, posing a risk to public health, as discussed by Esdaile & Chalker (2018), who highlighted the health risks associated with mercury and cyanide contamination in alluvial gold concentration.

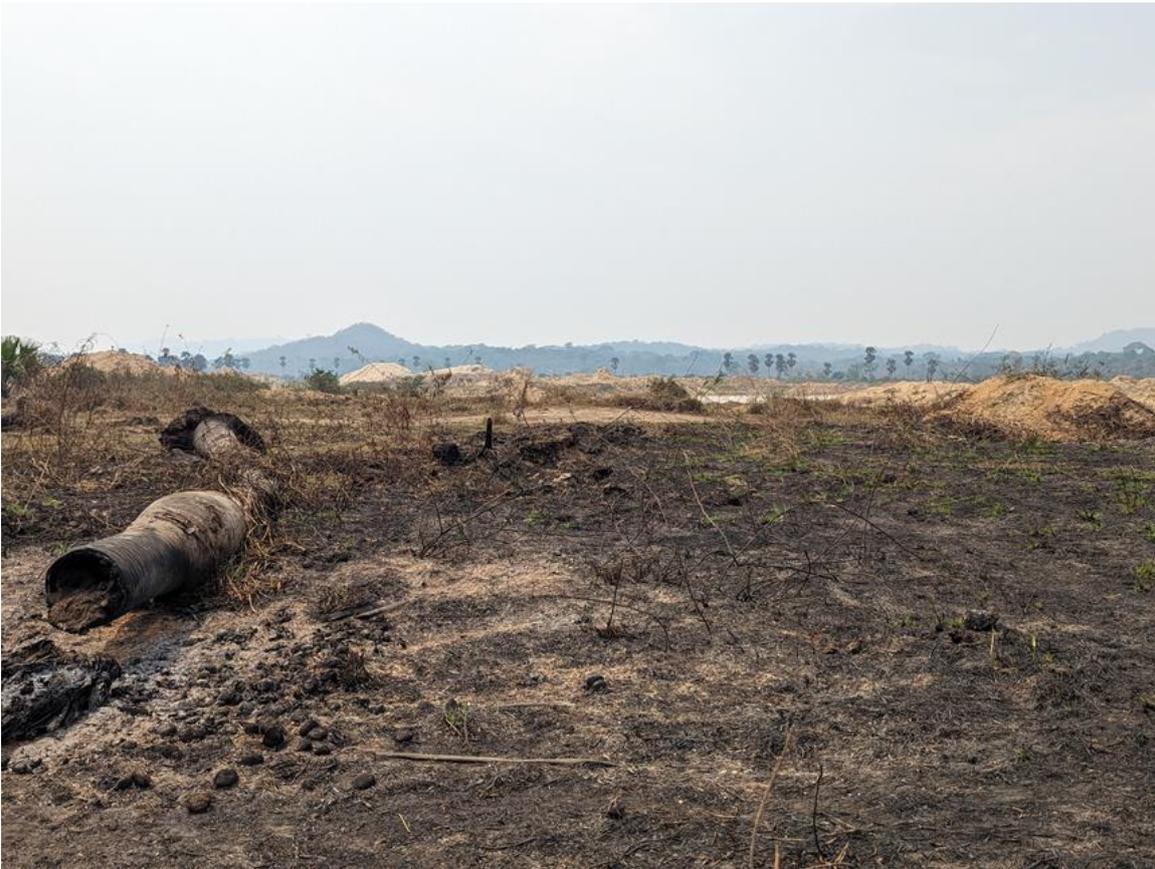
Figure 4.6: Deforested Area with Mining Pits in the Distance (Location: Bouli)

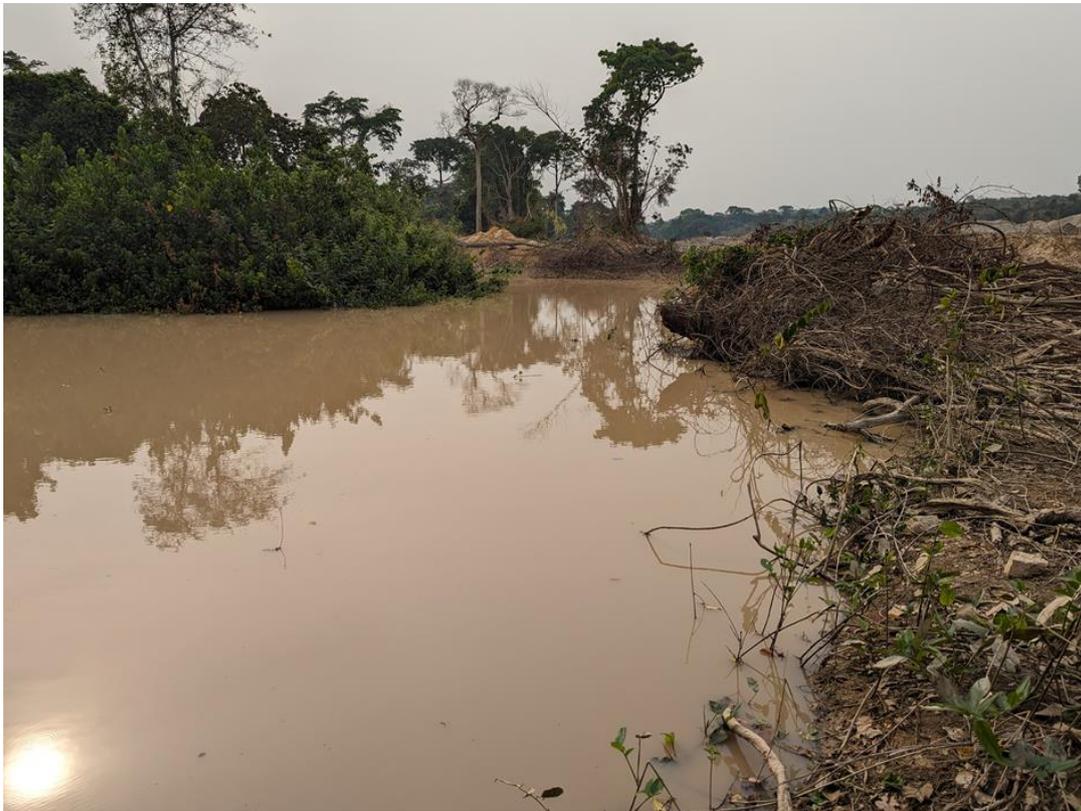
Figure 4.7: Turbid Water Flowing Through Mining-Affected Area (Location: Tributary of River Mari)

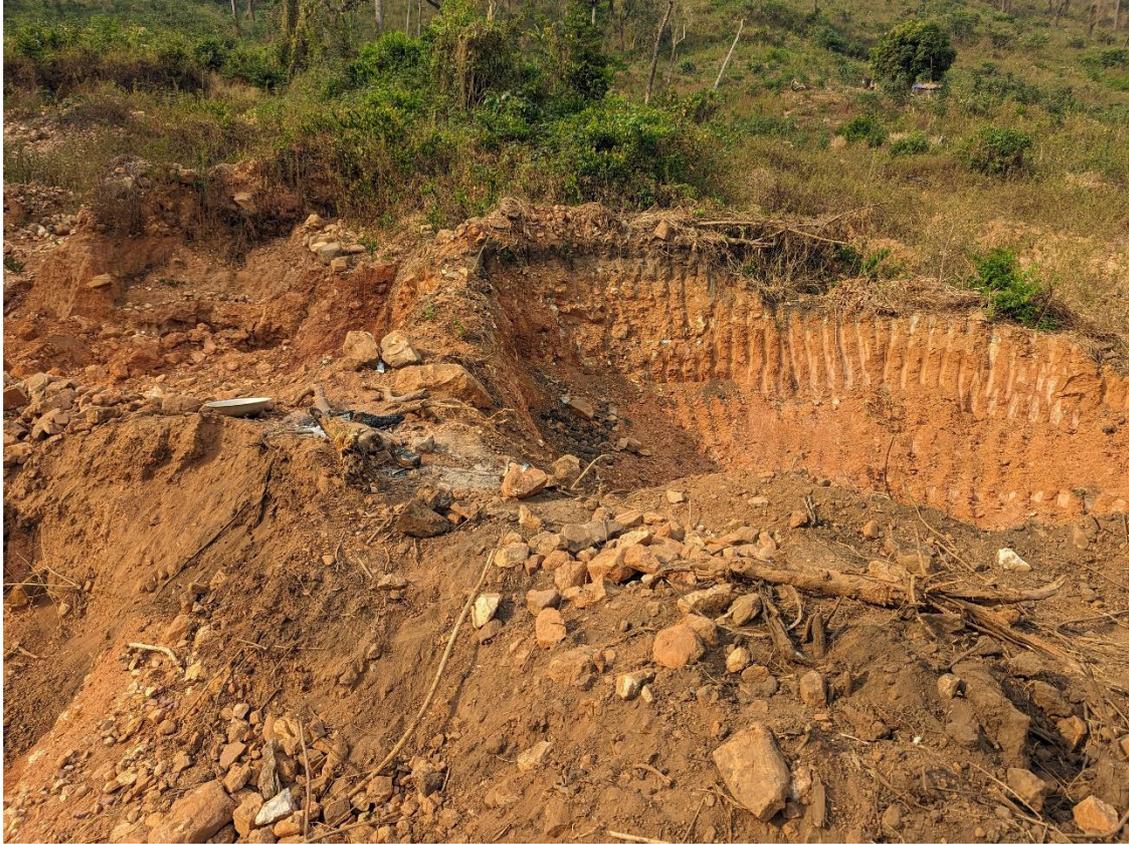
Figure 4.8: Exposed Soil Profile and Erosion Gullies (Location: Ngengue)

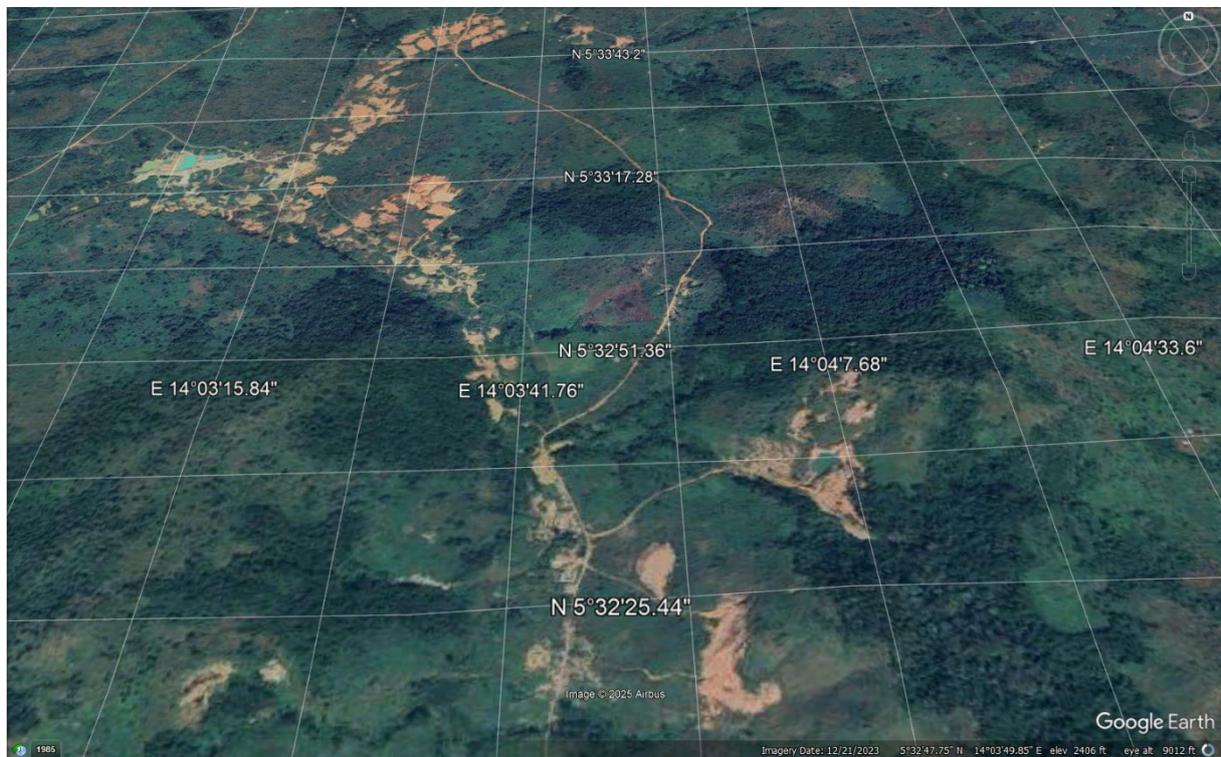
Figure 4.9: Google Earth Pro Image - Linear Mining Pattern (Location: N 5°33'43.2", E 14°03'15.84")

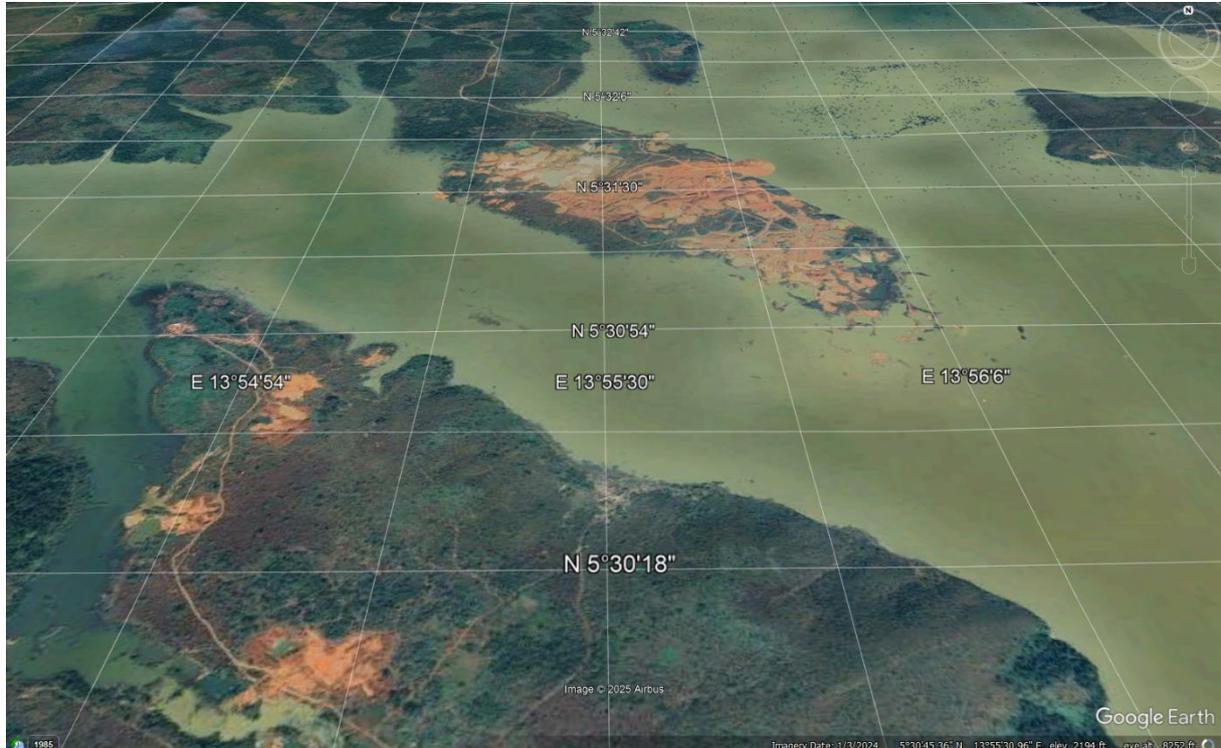
Figure 4.10: Google Earth Pro Image - Mining Area Adjacent to Water Body (Location: N 5°30'54", E 13°54'54")

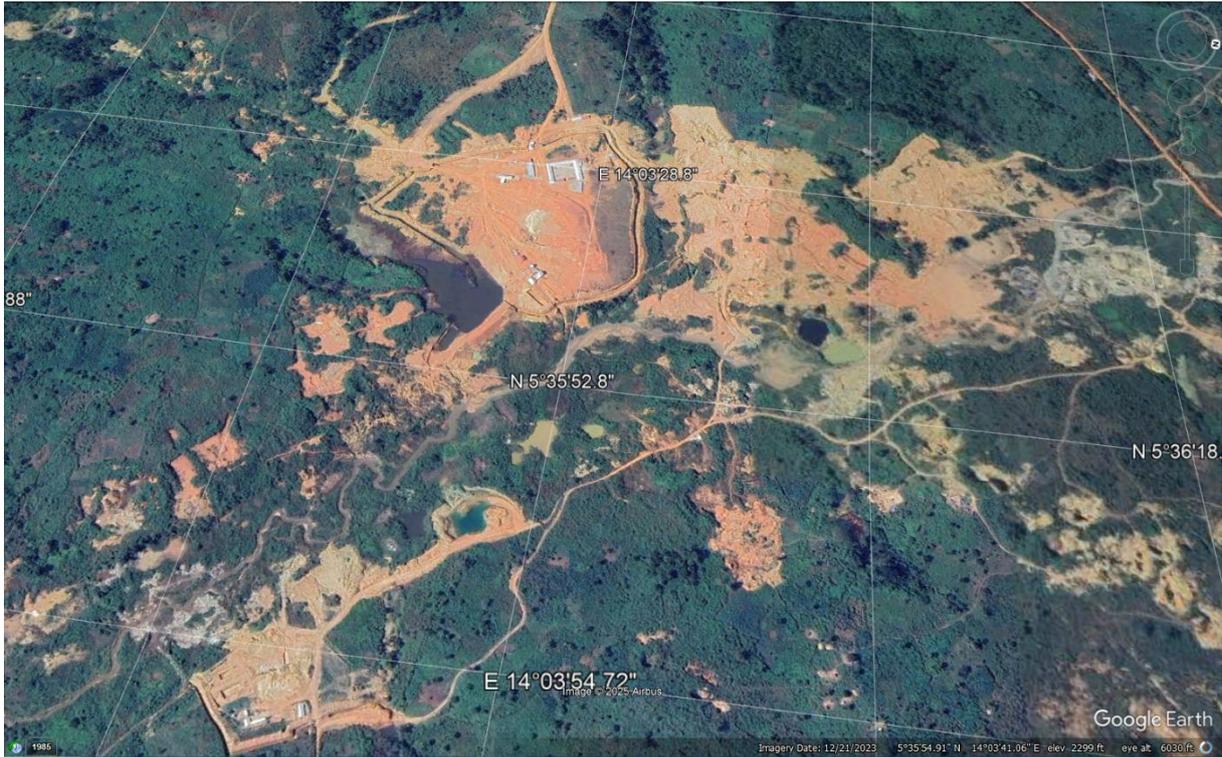
Figure 4.11 shows a Google Earth Pro image of a large-scale mining operation, characterized by extensive deforestation, large excavation pits, and processing facilities. The image reveals the scale of disturbance caused by mechanized mining activities and the significant impact on the landscape. The presence of processing facilities suggests that the mining operation is extracting and processing large quantities of ore, potentially leading to increased environmental impacts. This aligns with the findings of D'Souza (2020), who emphasized the severe environmental degradation, including land degradation, deforestation, and biodiversity loss, resulting from artisanal and small-scale mining in Africa. Also, the image reveals a landscape dominated by bare earth, with limited vegetation cover and altered drainage patterns. The photograph highlights the direct link between gold mining and deforestation, which can have significant impacts on biodiversity, carbon sequestration, and climate change, as noted by Sonwa et al. (2020), who documented extensive deforestation due to gold mining, agriculture, and logging in the Betaré-Oya region.

Figure 4.11: Google Earth Pro Image - Large-Scale Mining Operation (Location: N 5°35'52.8", E 14°03'38.8")

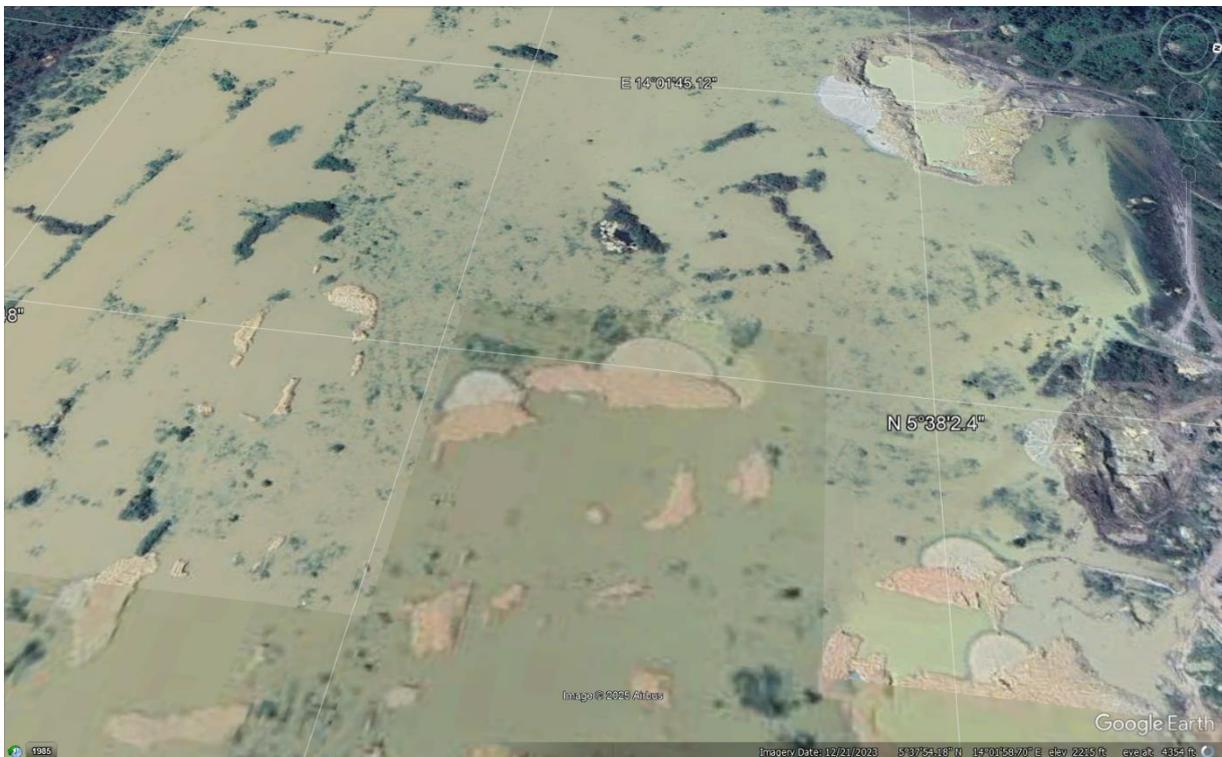
Figure 4.12: Google Earth Pro Image - Flooded Mining Area (Location: N 5°38'2.4", E 14°16'45.92")

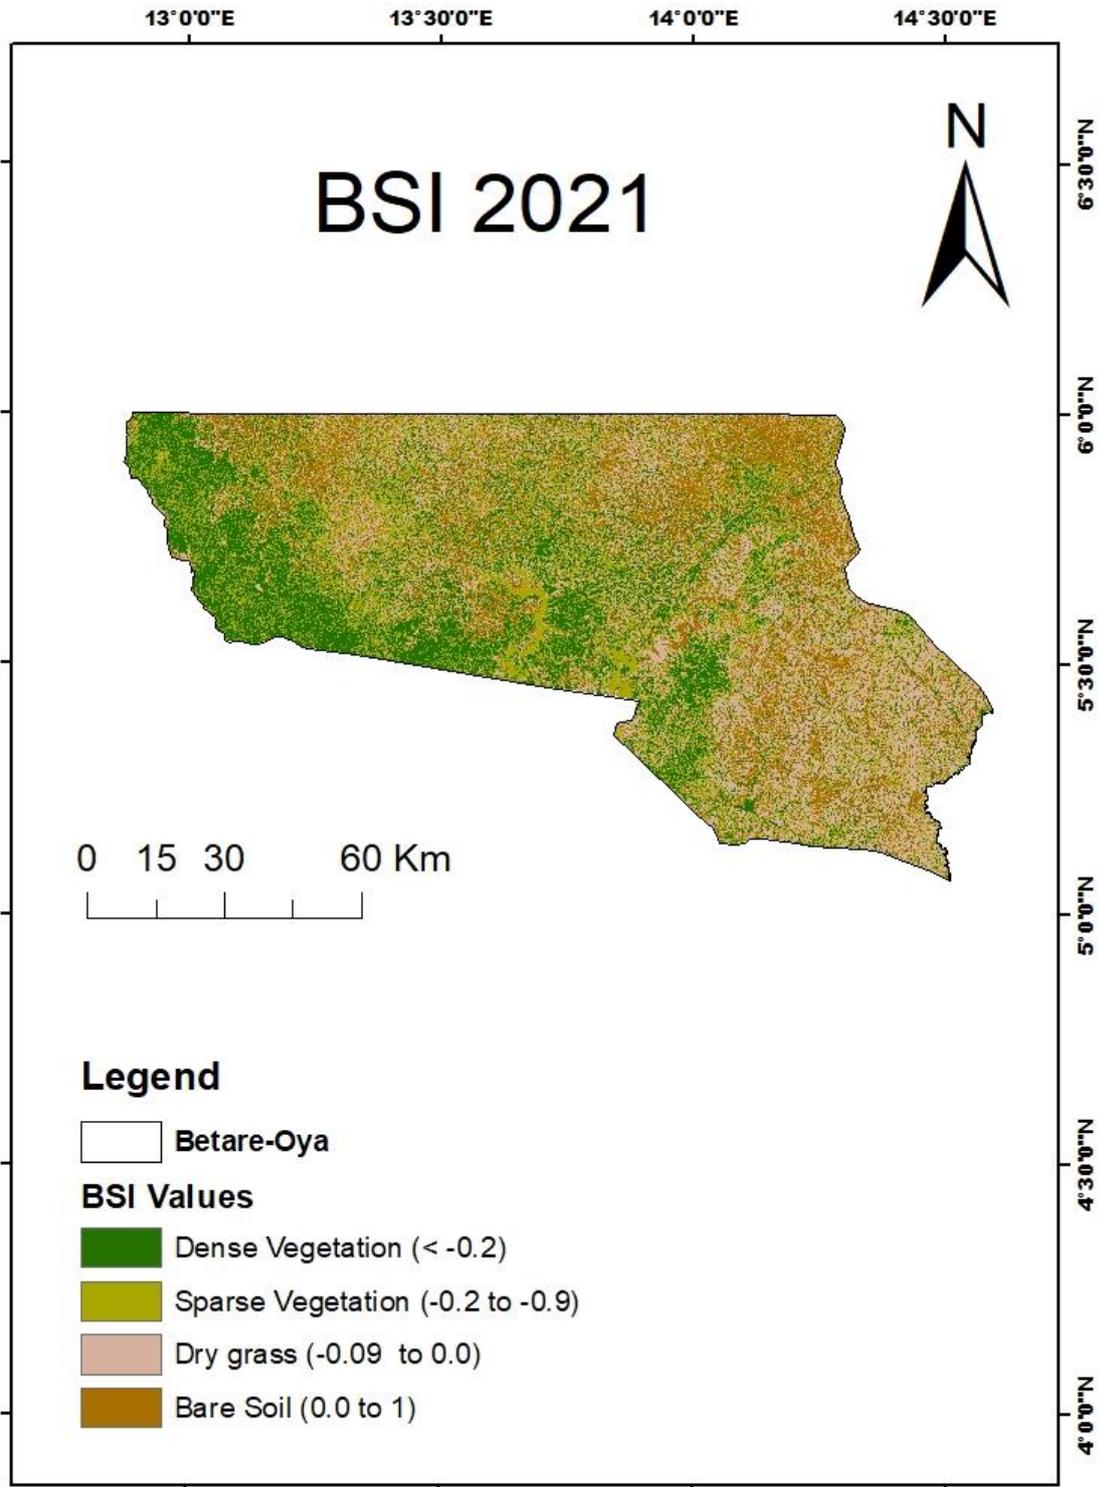
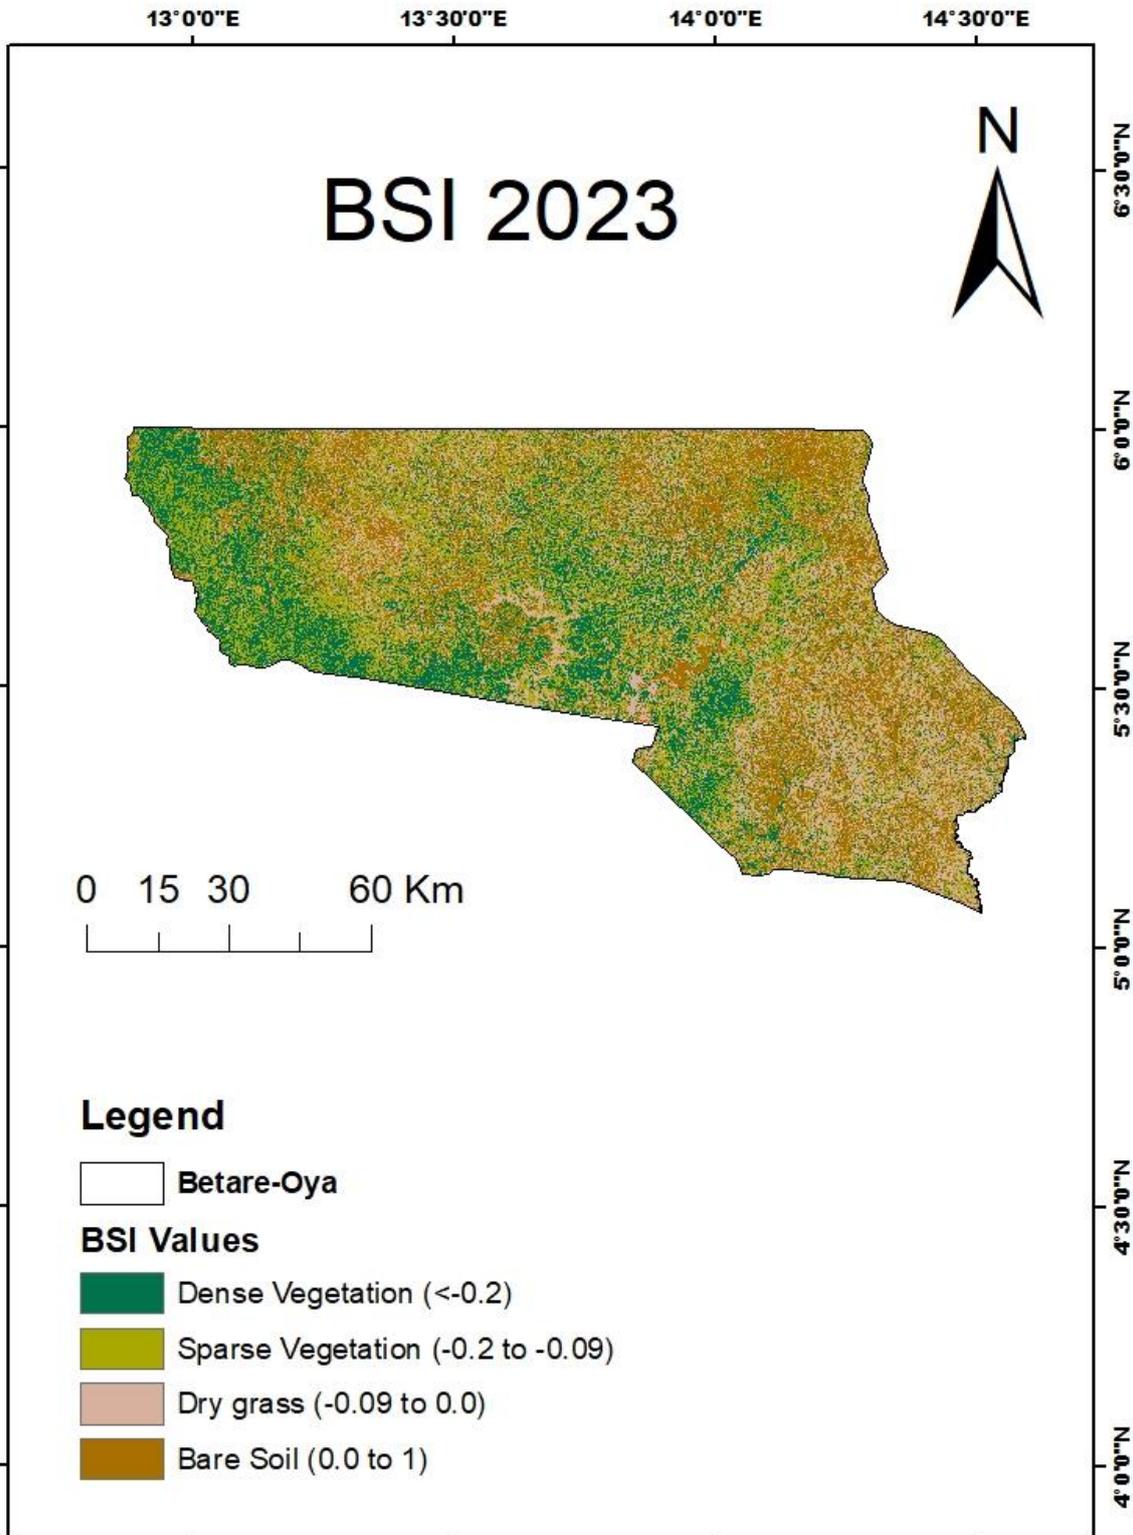
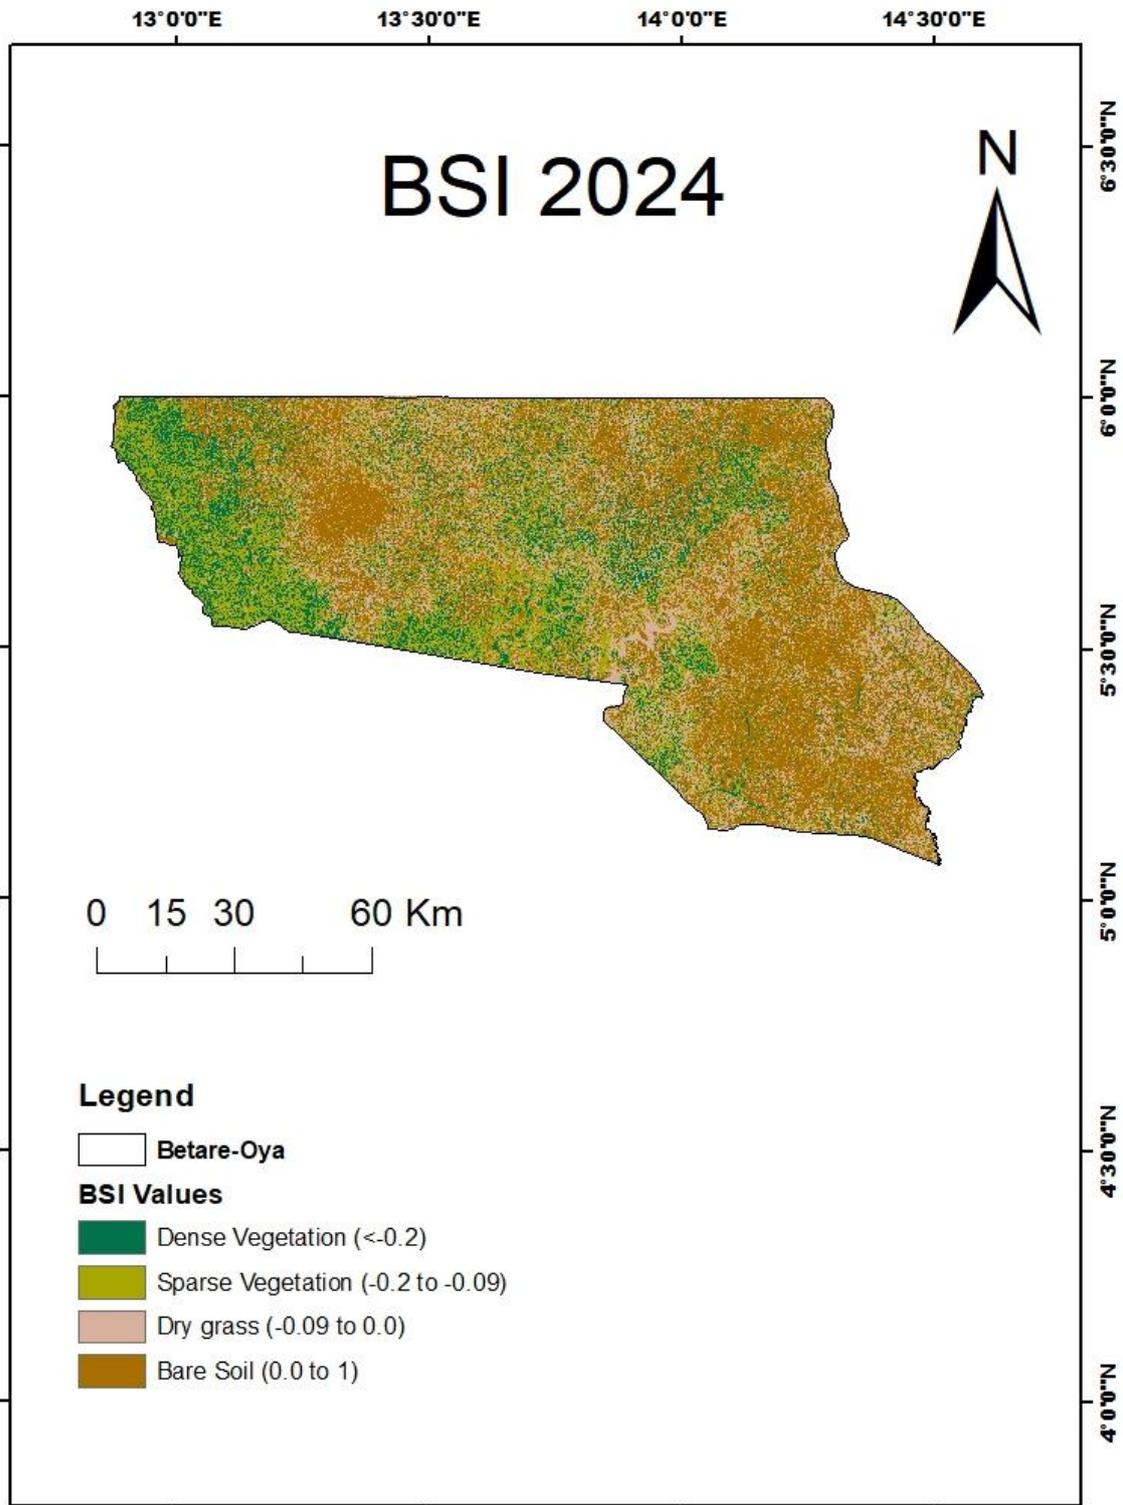
spatial patterns of BSI change appear to be strongly correlated with the locations of mining activities, suggesting a direct link between mining and land degradation.

Figure 4.14: BSI for 2021

Figure 4.15: BSI for 2023

Figure 4.16: BSI for 2024

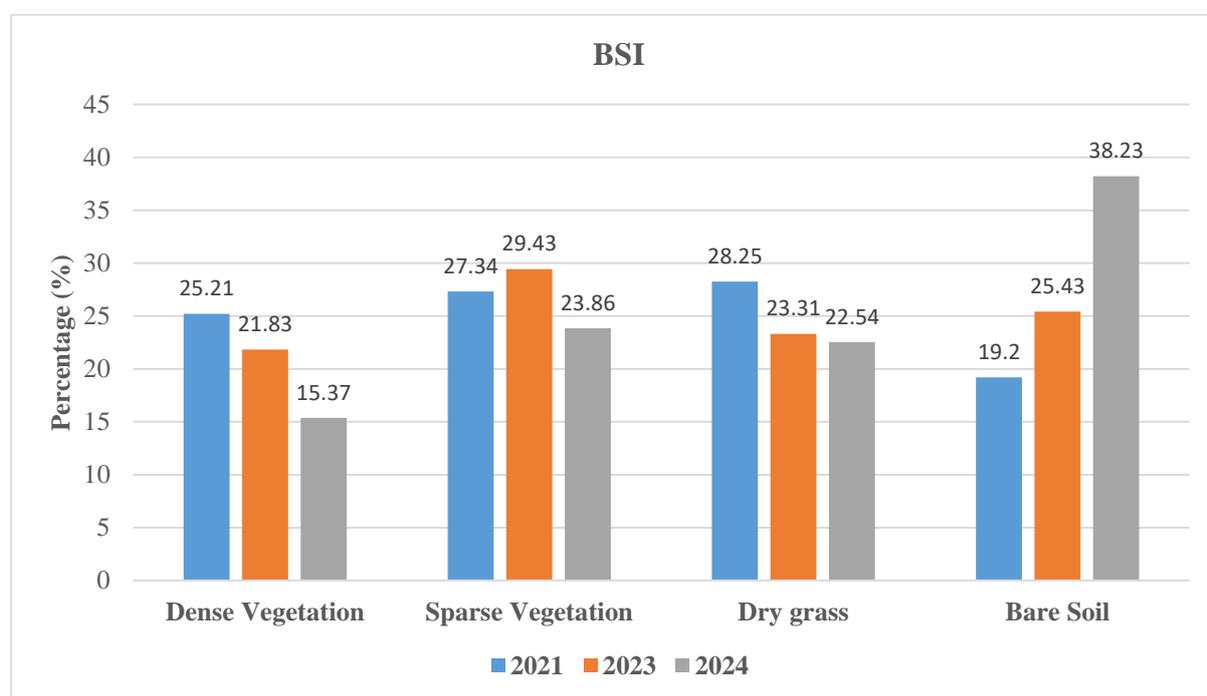
Figure 4.17: BSI trend from 2021 to 2024
