**SPATIOTEMPORAL ANALYSIS AND
REHABILITATION OF ALLUVIAL GOLD
MINING-AFFECTED AREAS IN BETARÉ-OYA,
CAMEROON (2021-2025) USING REMOTE
SENSING**

A DISSERTATION

Presented to the
Department of Mining Engineering
Program at Selinus University

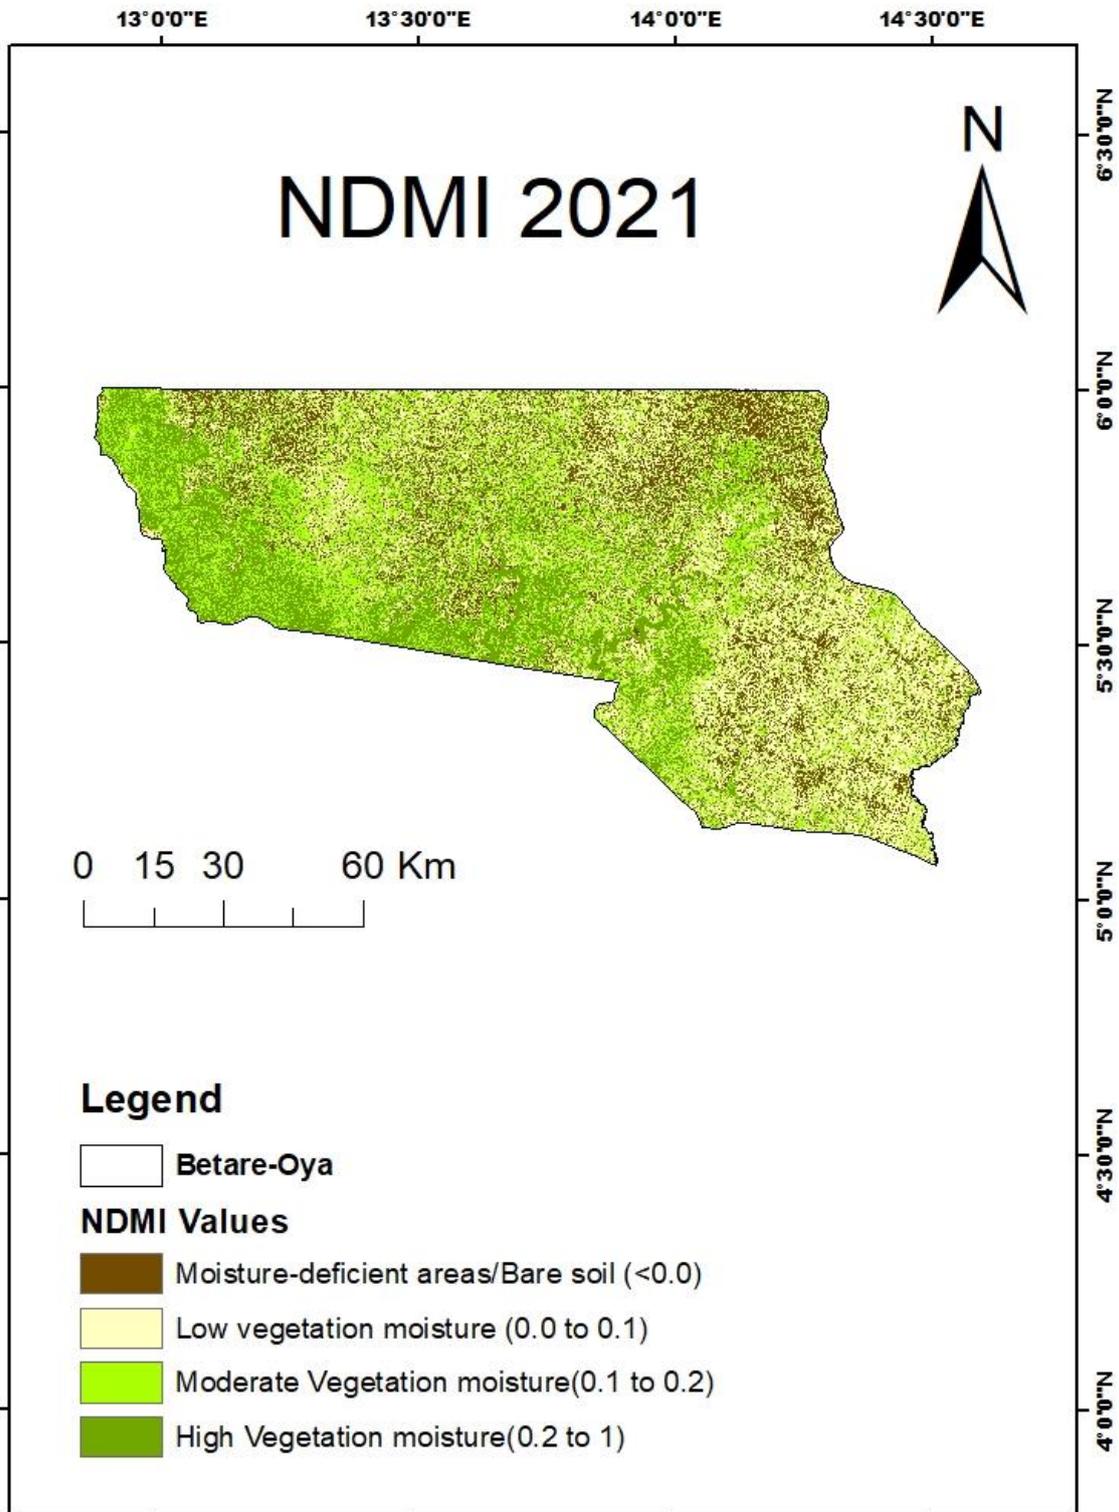
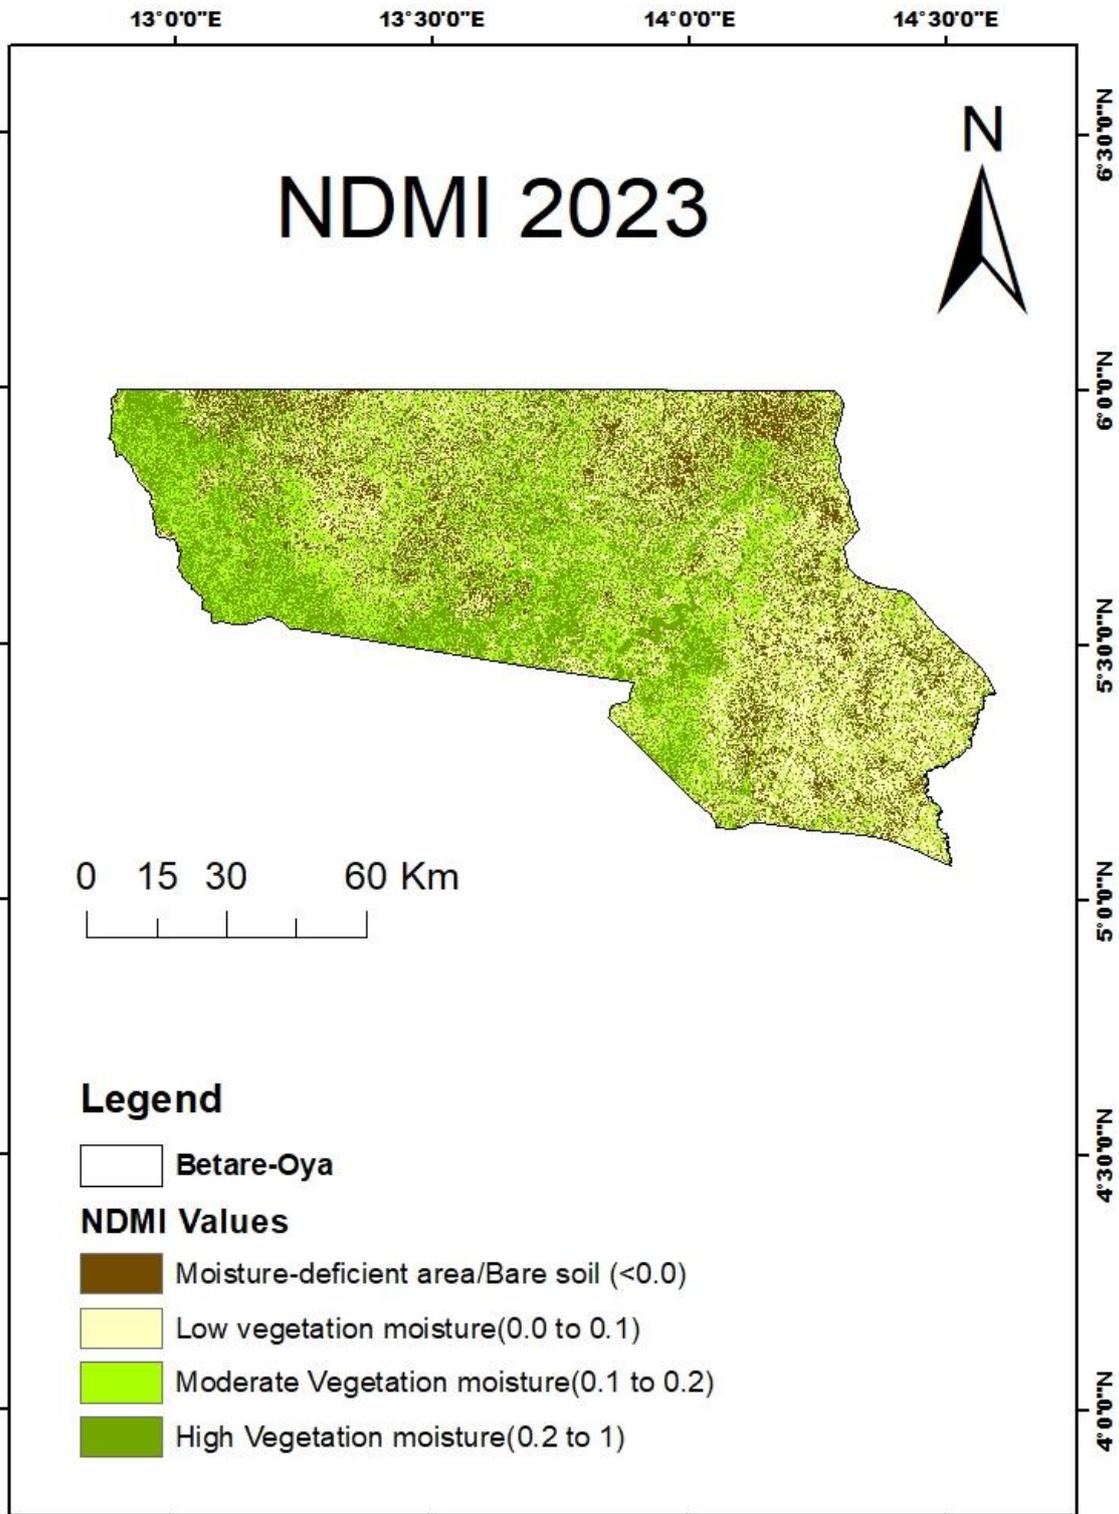
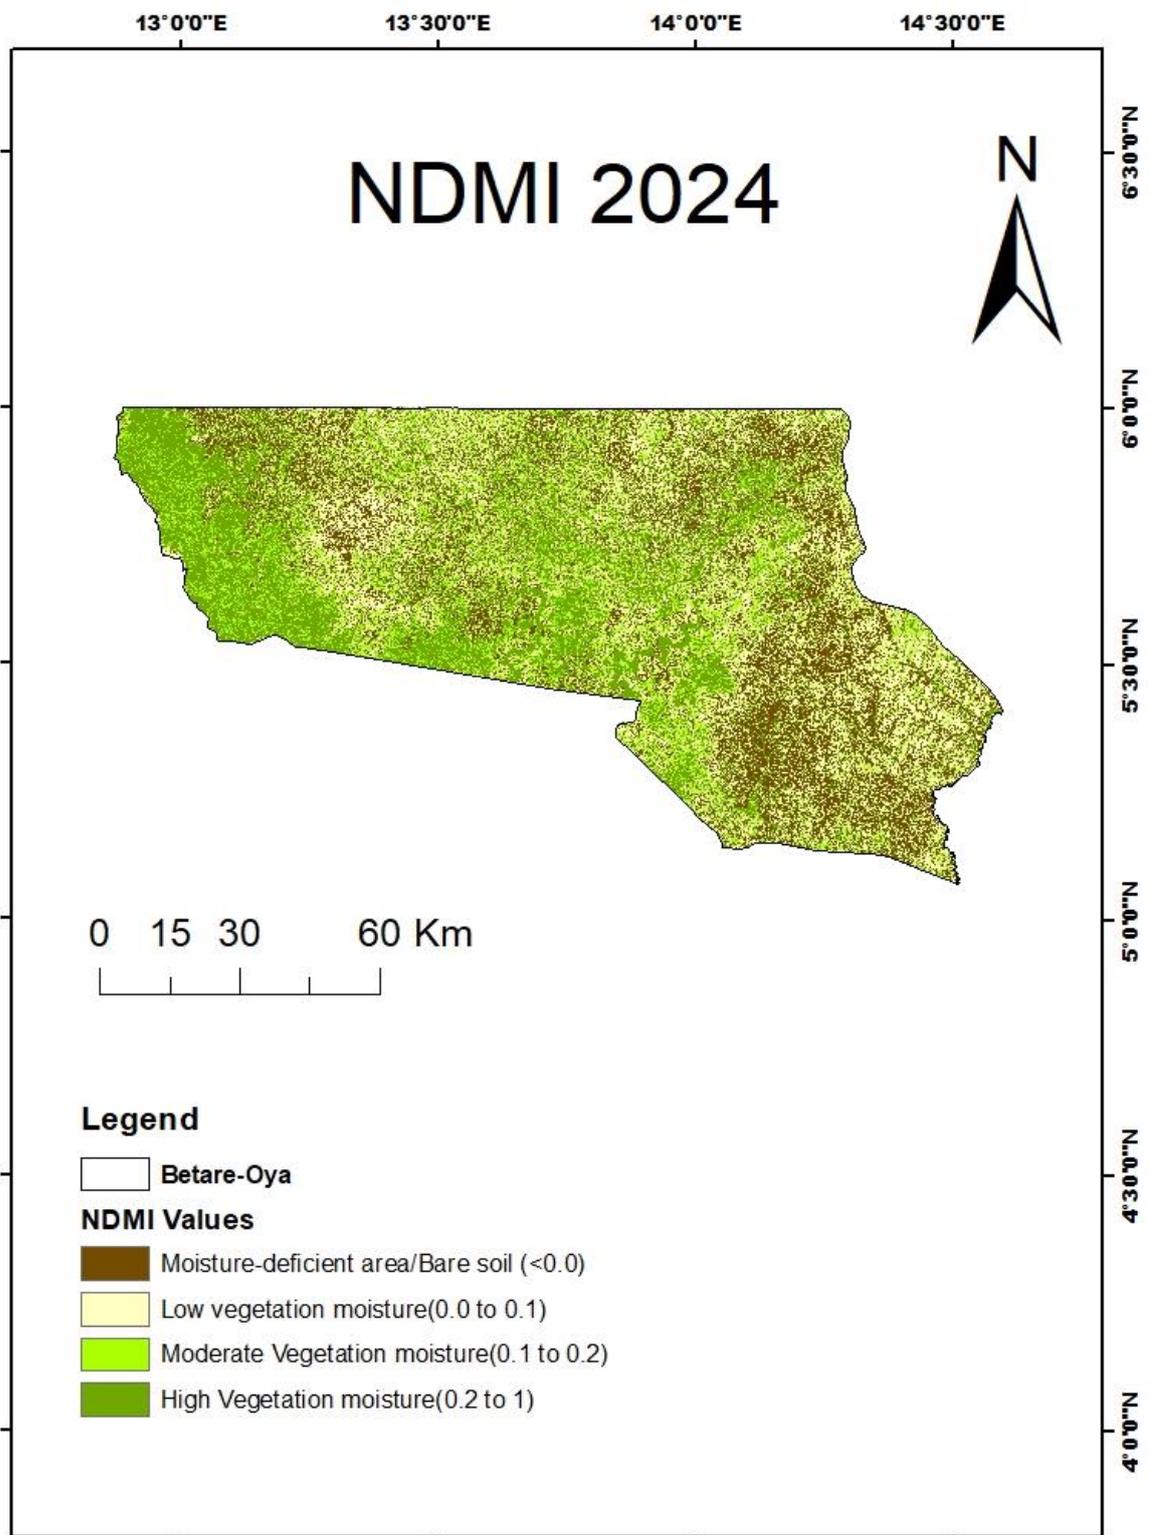
Figure 4.18: NDMI for 2021

Figure 4.19: NDMI for 2023

Figure 4.19: NDMI for 2024

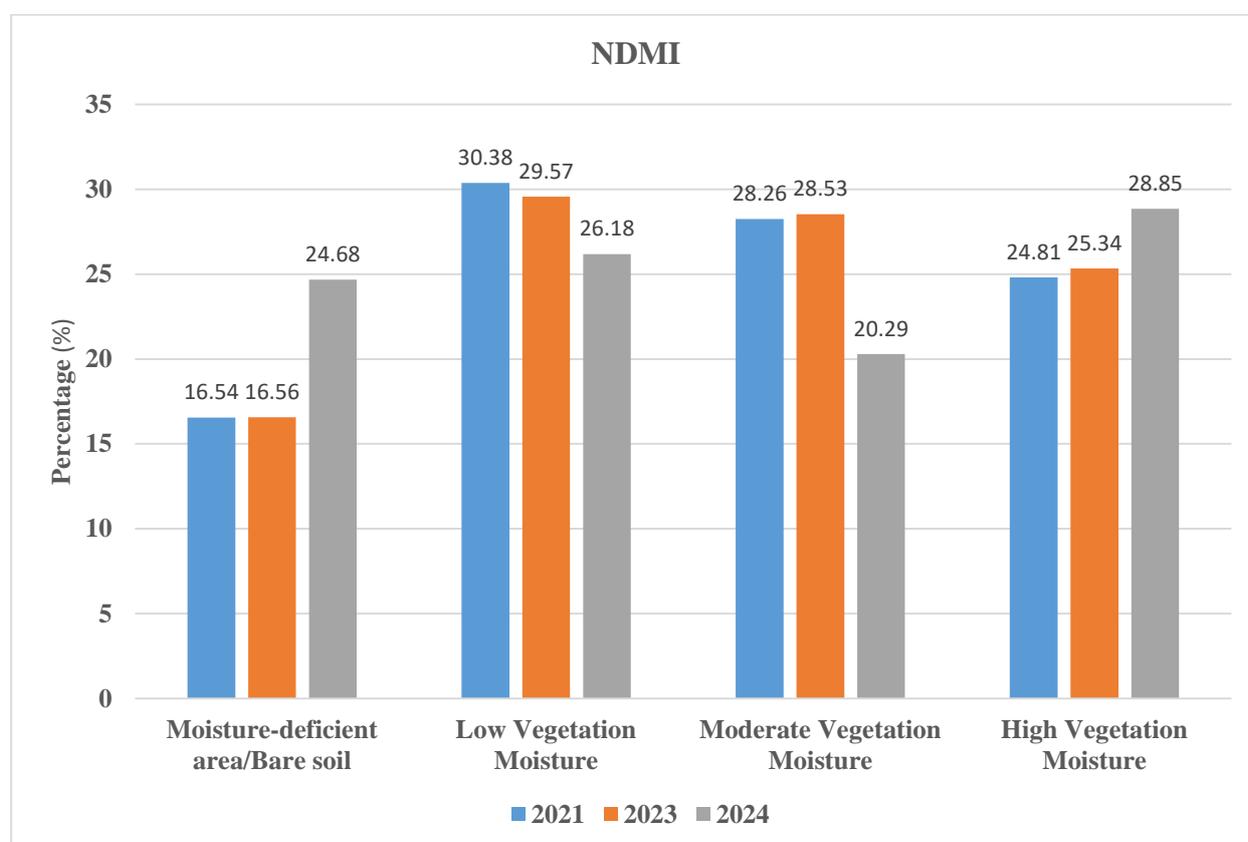
The NDMI trend from 2021 to 2024 (Figure 4.20) visually summarizes the changes in vegetation moisture content over time. The graph shows a consistent decline in the percentage of low and moderate vegetation moisture and an increase in the percentage of moisture-deficient areas/bare soil. This trend suggests that mining activities are having a negative impact on vegetation moisture in the Betaré-Oya region.

Figure 4.20: NDMI trend from 2021 to 2024

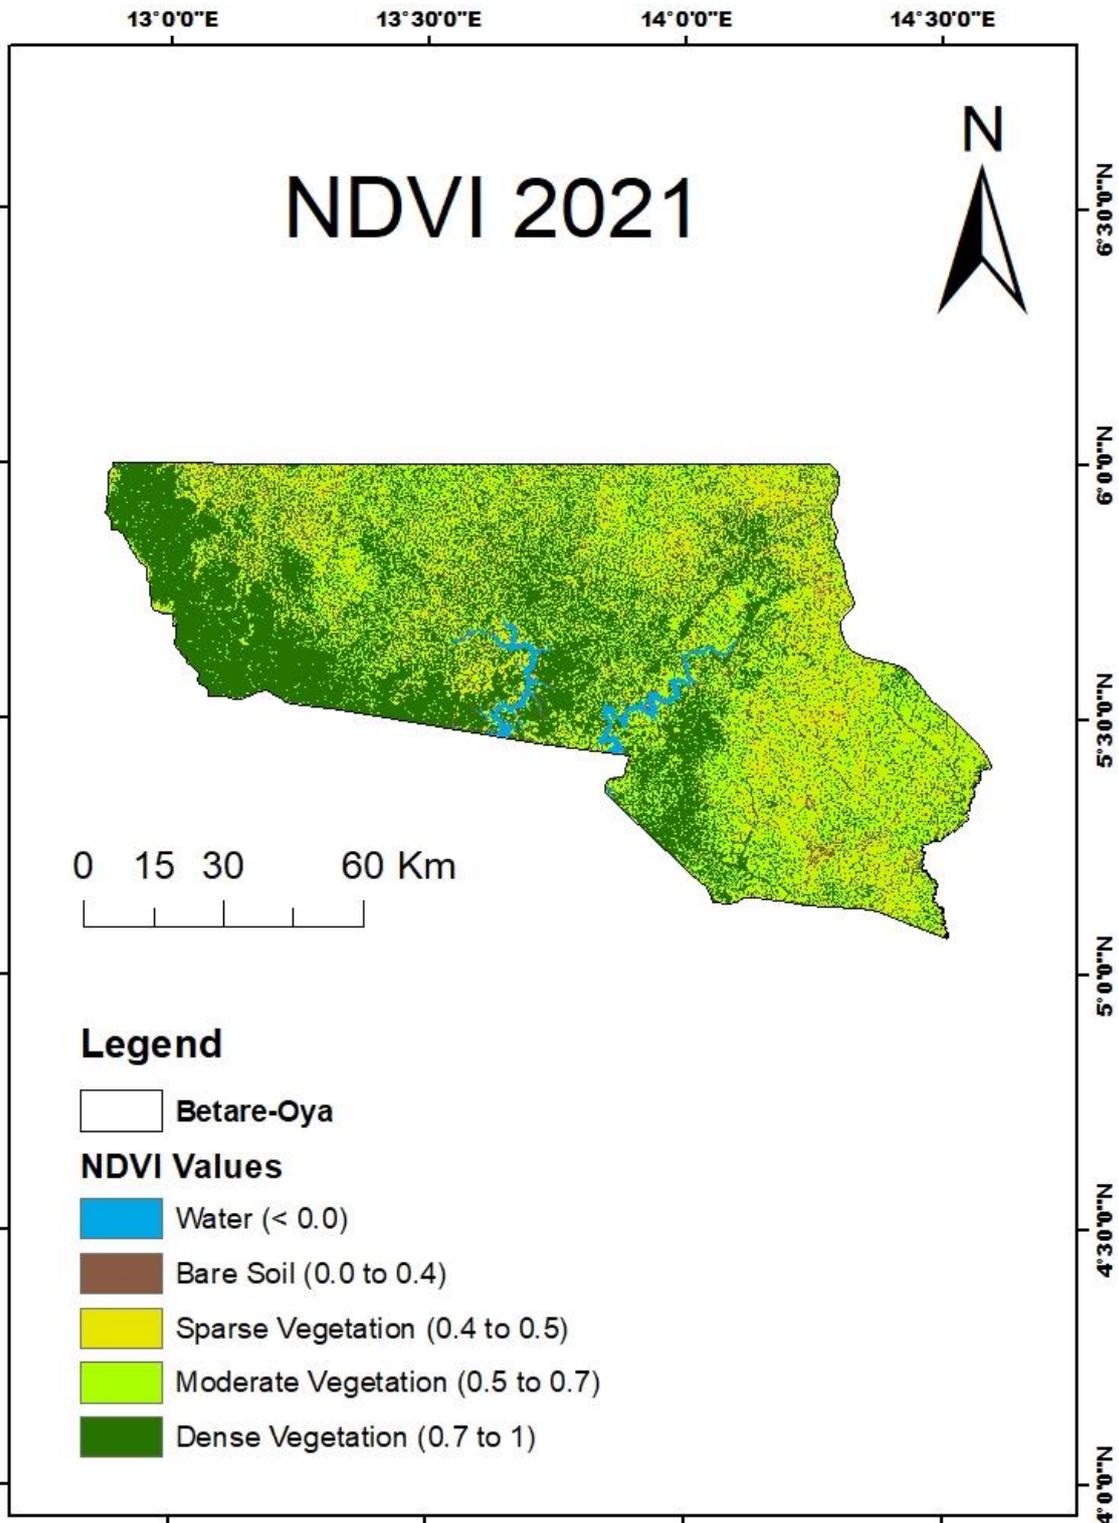
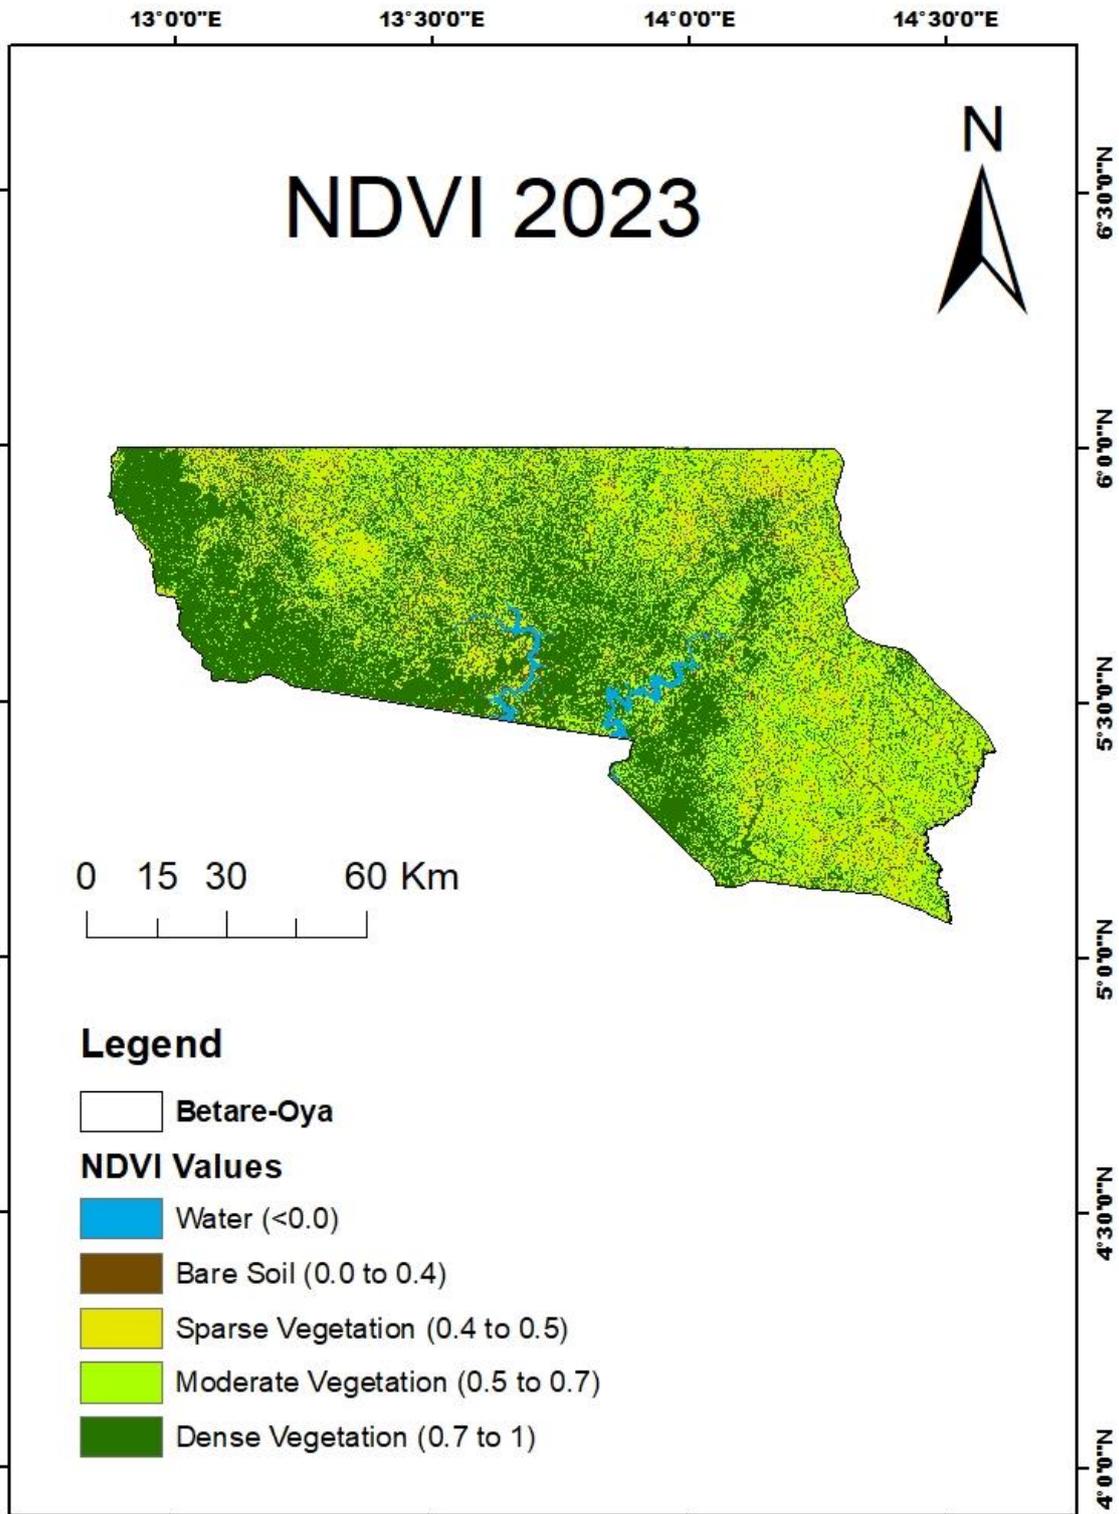
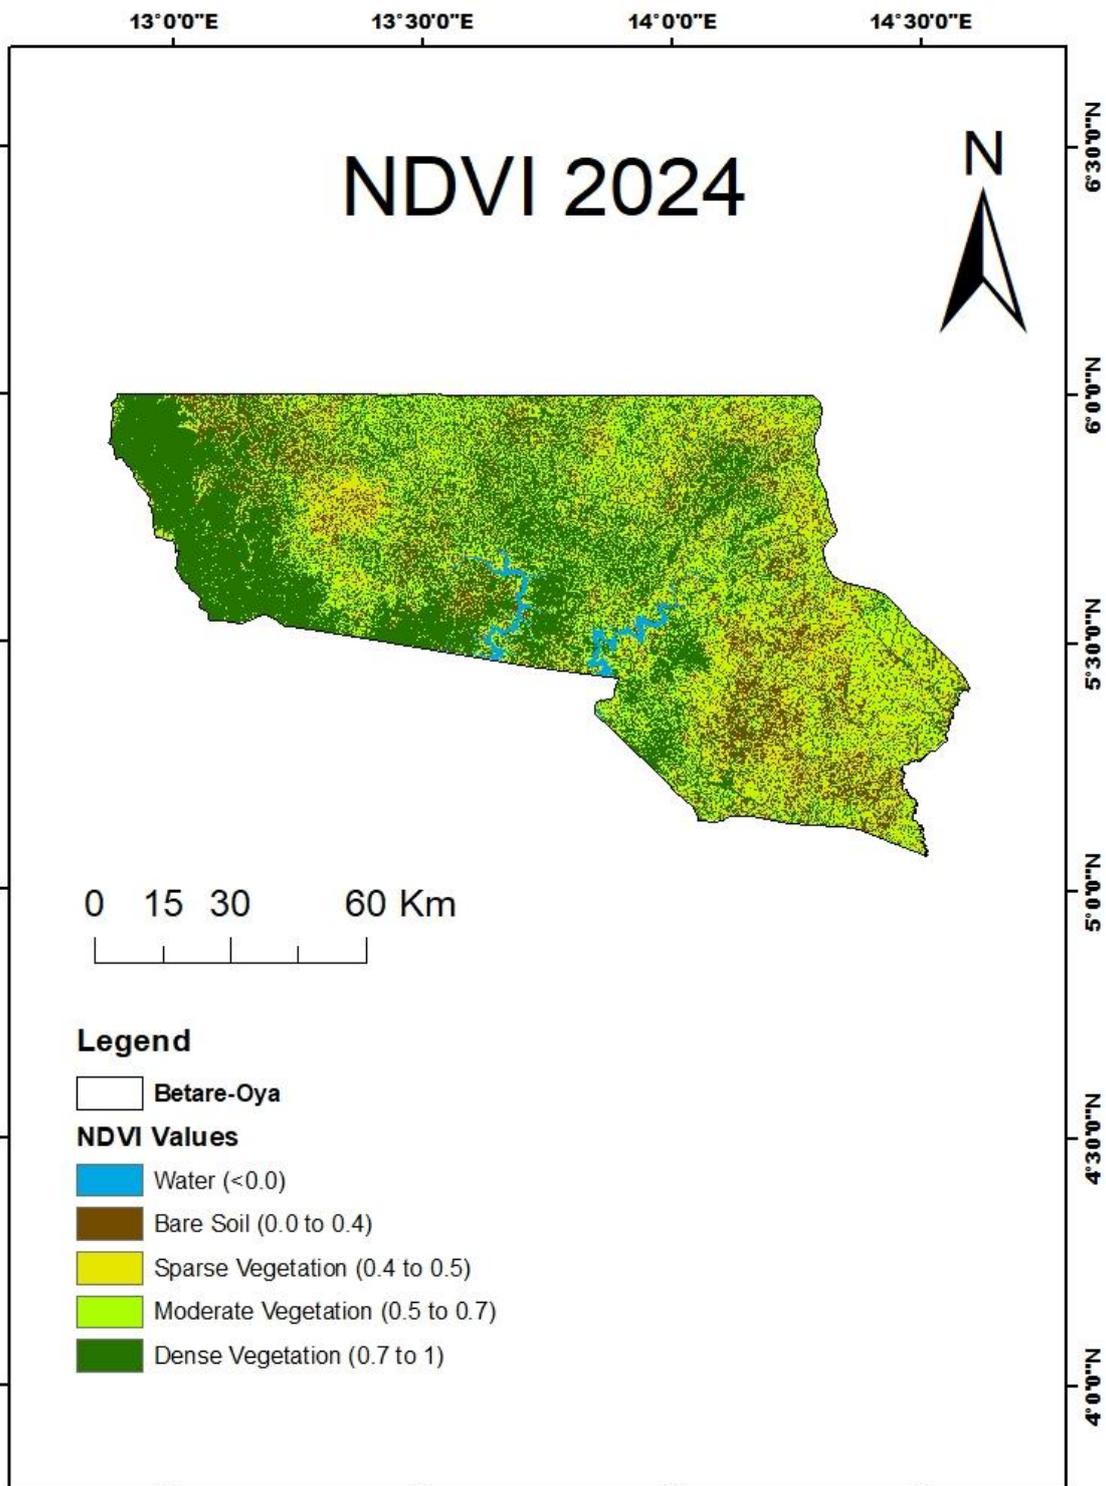
The NDVI maps (Figures 4.21, 4.22, and 4.23) provide a visual representation of vegetation health across the Betaré-Oya region. In 2021, the maps show a relatively high proportion of dense vegetation, particularly in the northern and western parts of the study area. However, by 2023, a noticeable decline in dense vegetation is evident, with a corresponding increase in areas classified as sparse vegetation and bare soil. This trend continues in 2024, with further fragmentation of dense vegetation patches and expansion of degraded areas. The NDVI statistics (Table 4.3) provide a quantitative assessment of vegetation health changes. The area of dense vegetation decreased from 46.13% in 2021 to 42.34% in 2024, representing a significant loss of vegetation cover. Conversely, the area of bare soil increased from 1.82% in 2021 to 12.55% in 2024, indicating a substantial increase in land degradation. The areas classified as sparse vegetation and moderate vegetation also showed fluctuations, suggesting a dynamic response of vegetation to mining-related disturbances.

Figure 4.21: NDVI for 2021

Figure 4.23: NDVI for 2023

Figure 4.24: NDVI for 2024

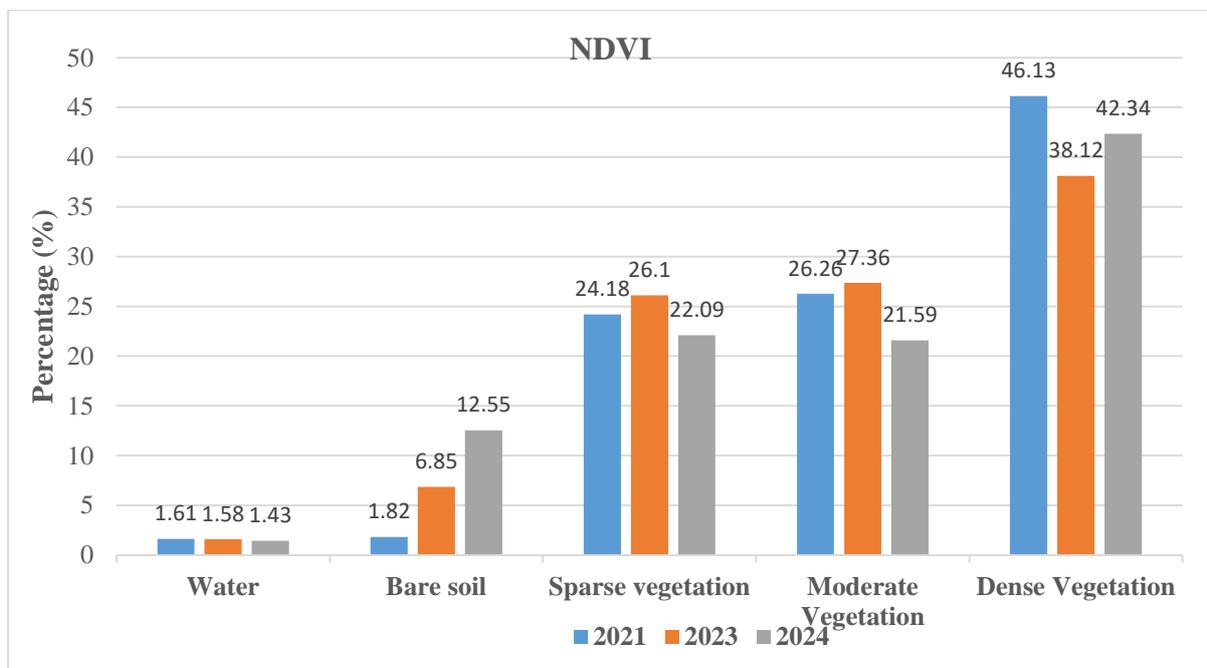
Figure 4.25: NDVI trend from 2021 to 2024

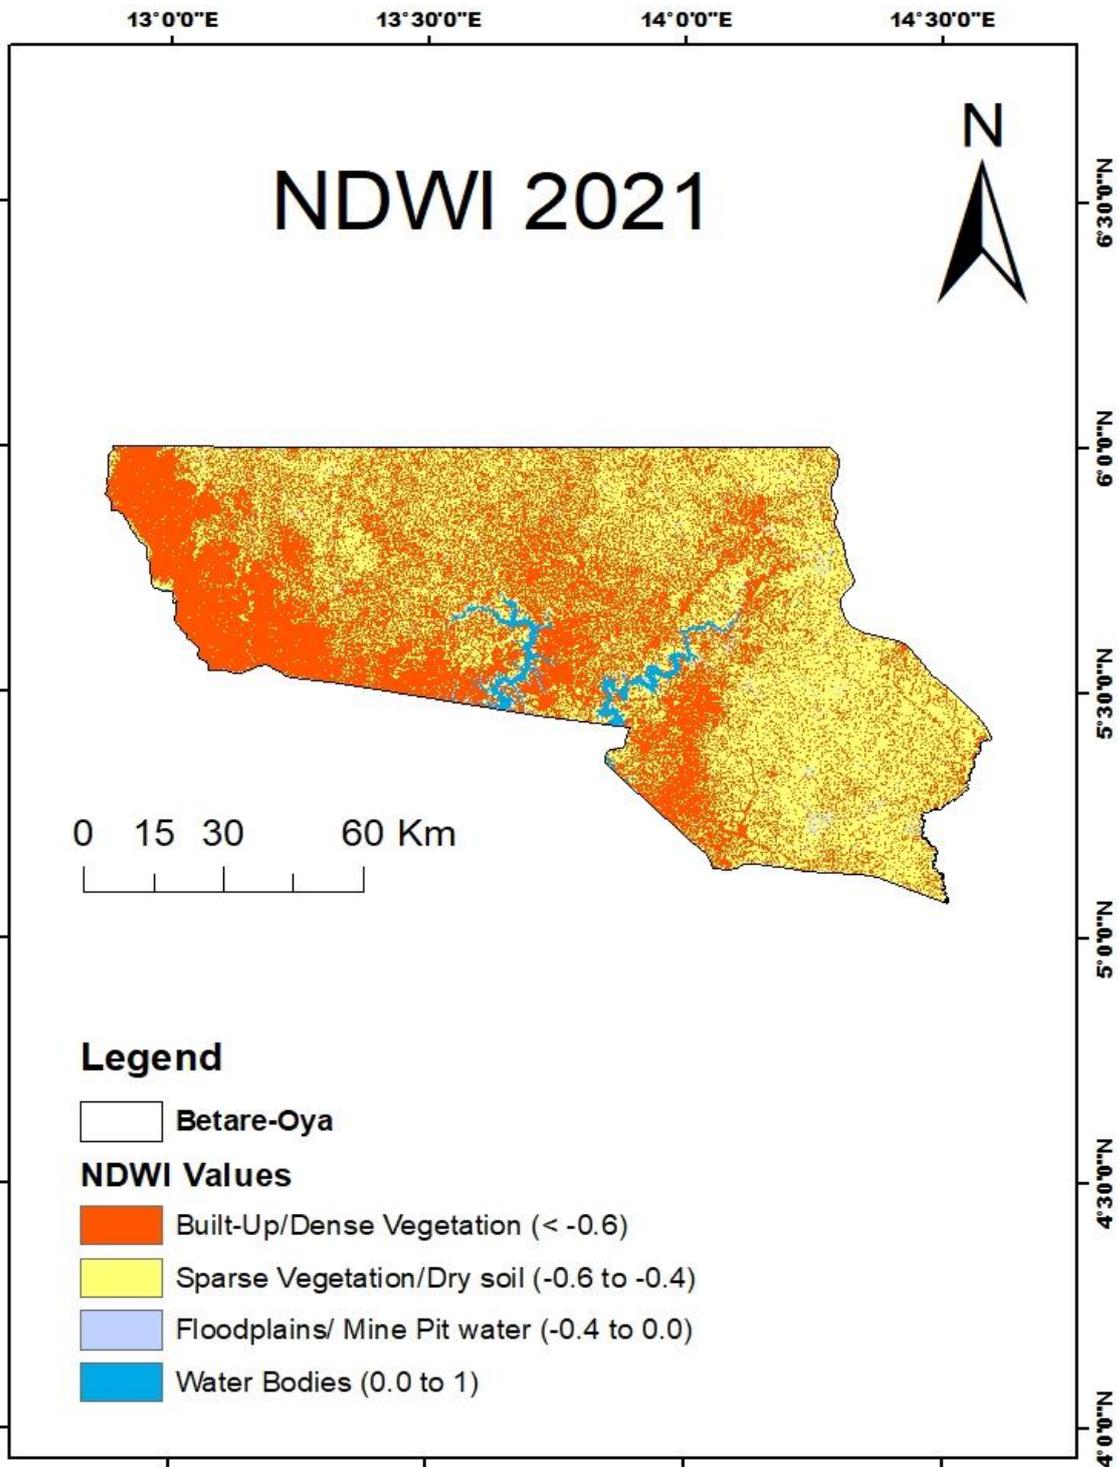
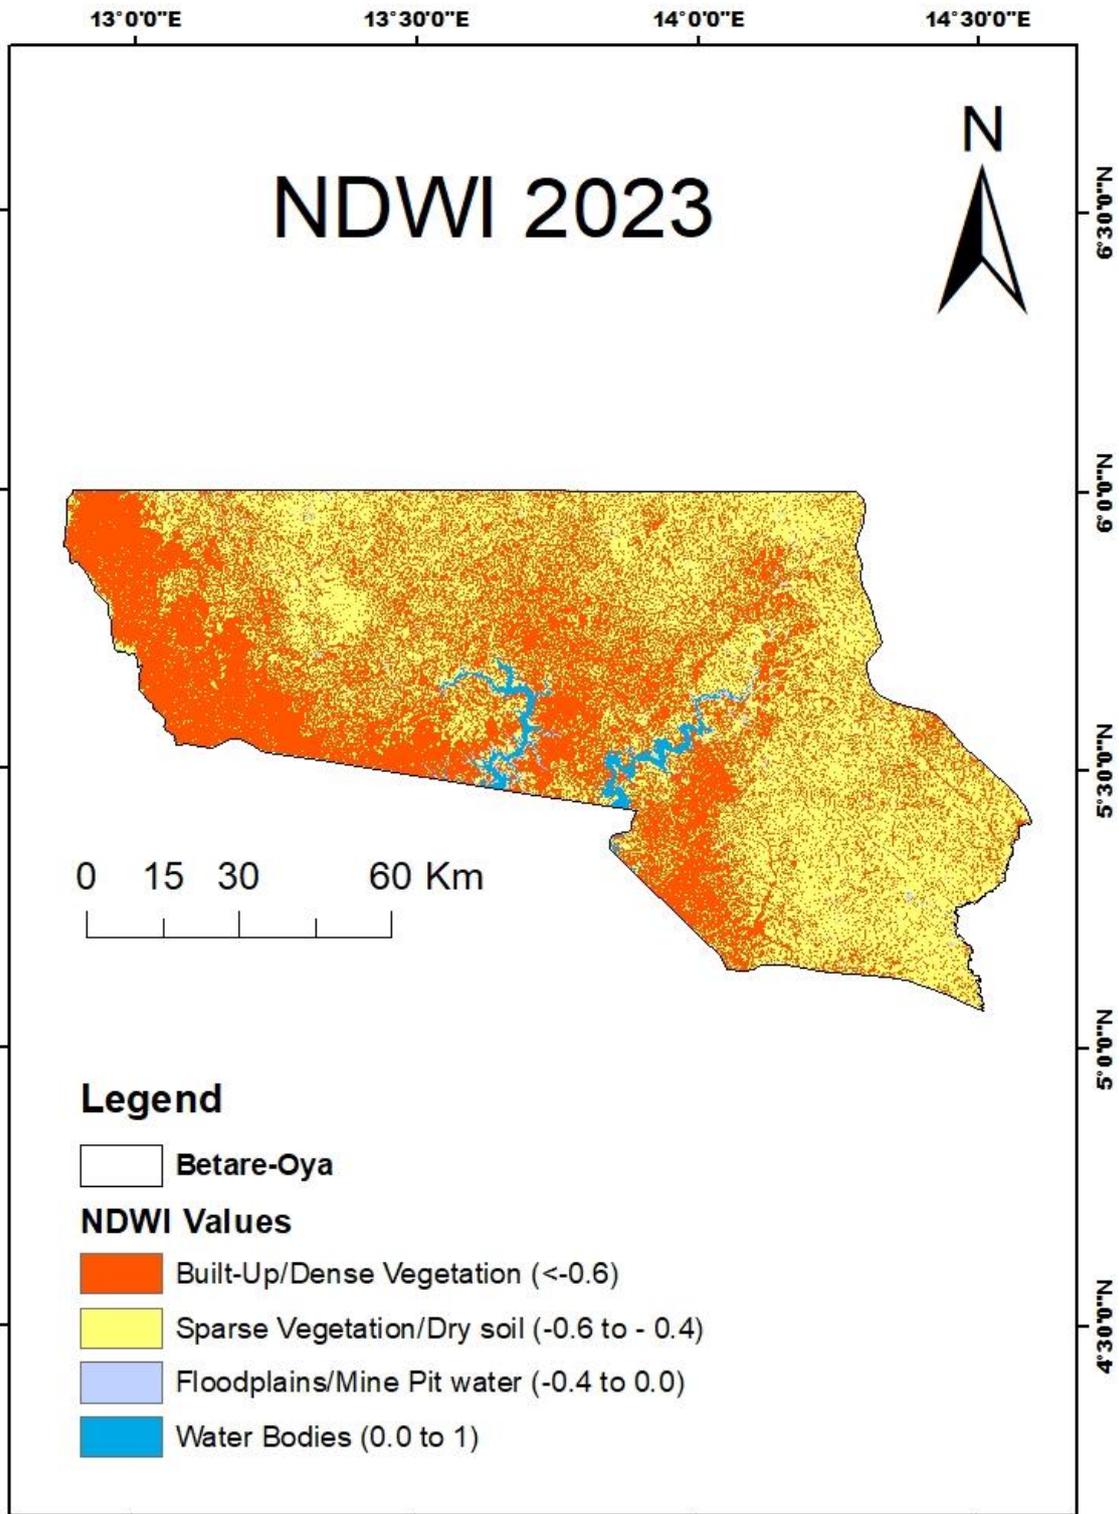
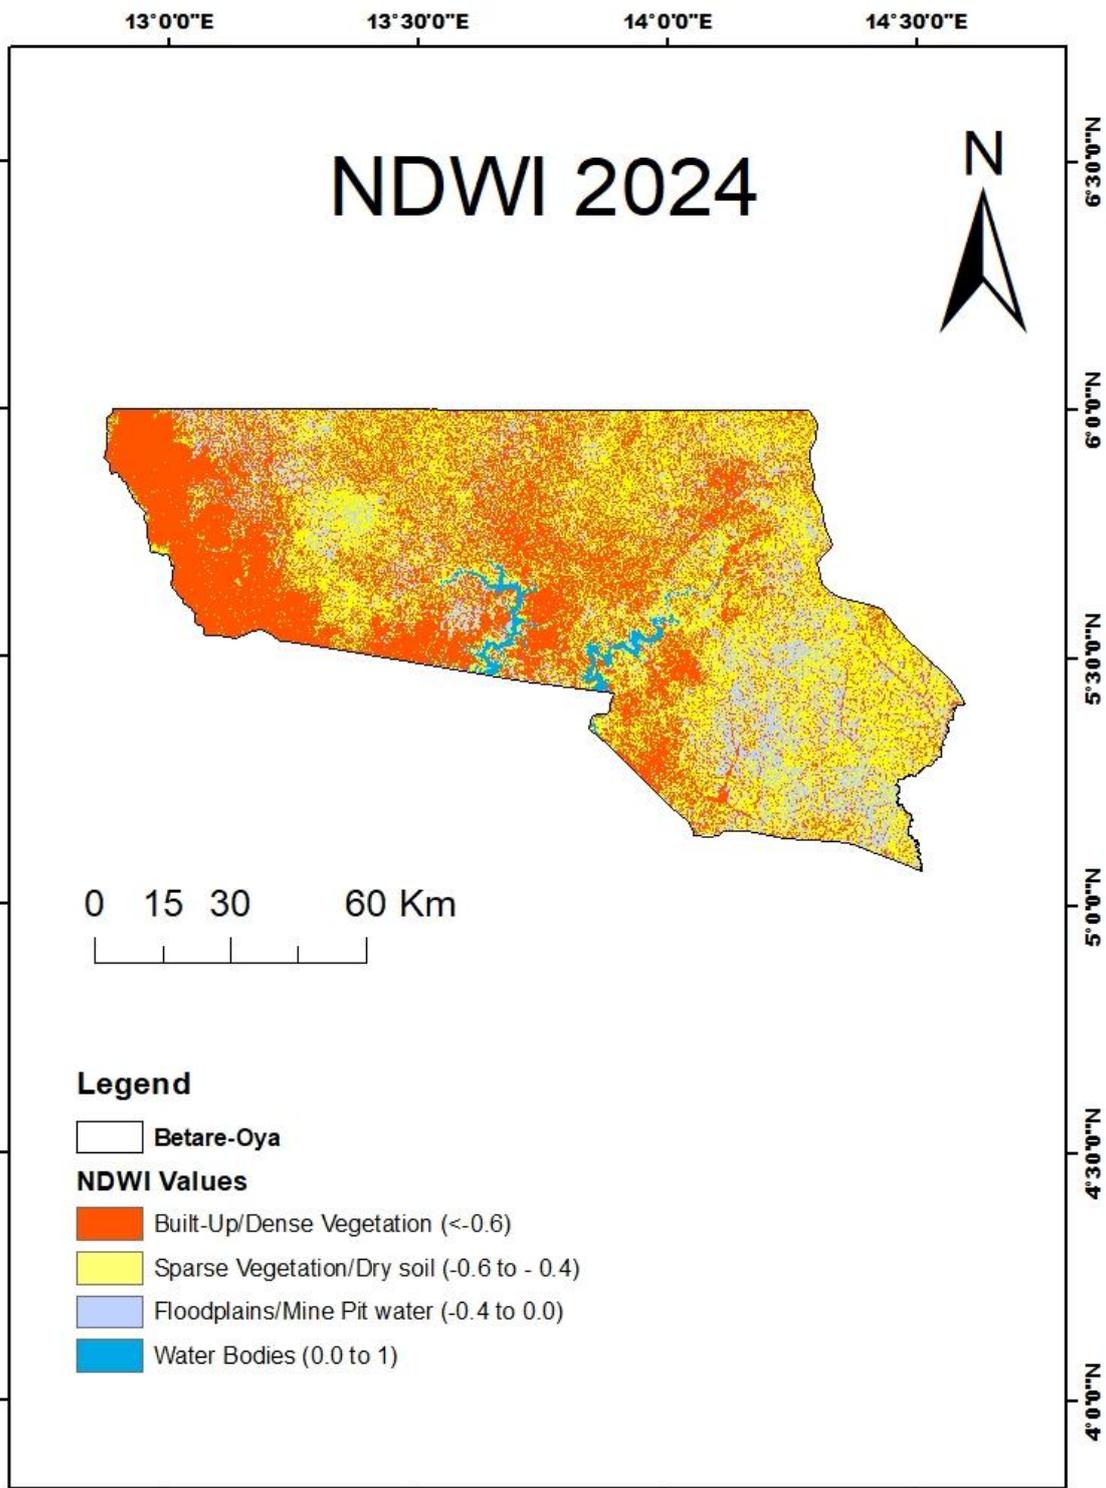
The NDWI statistics (Table 4.4) provide a quantitative assessment of water body changes. The area of water bodies decreased from 1.71% in 2021 to 1.49% in 2024, representing a significant loss of water resources. Conversely, the area of floodplains/mine pit water increased from 1.41% in 2021 to 17.52% in 2024, indicating a substantial increase in areas affected by mining-related water disturbances.

Figure 4.26: NDWI for 2021

Figure 4.27: NDWI for 2023

Figure 4.28: NDWI for 2024

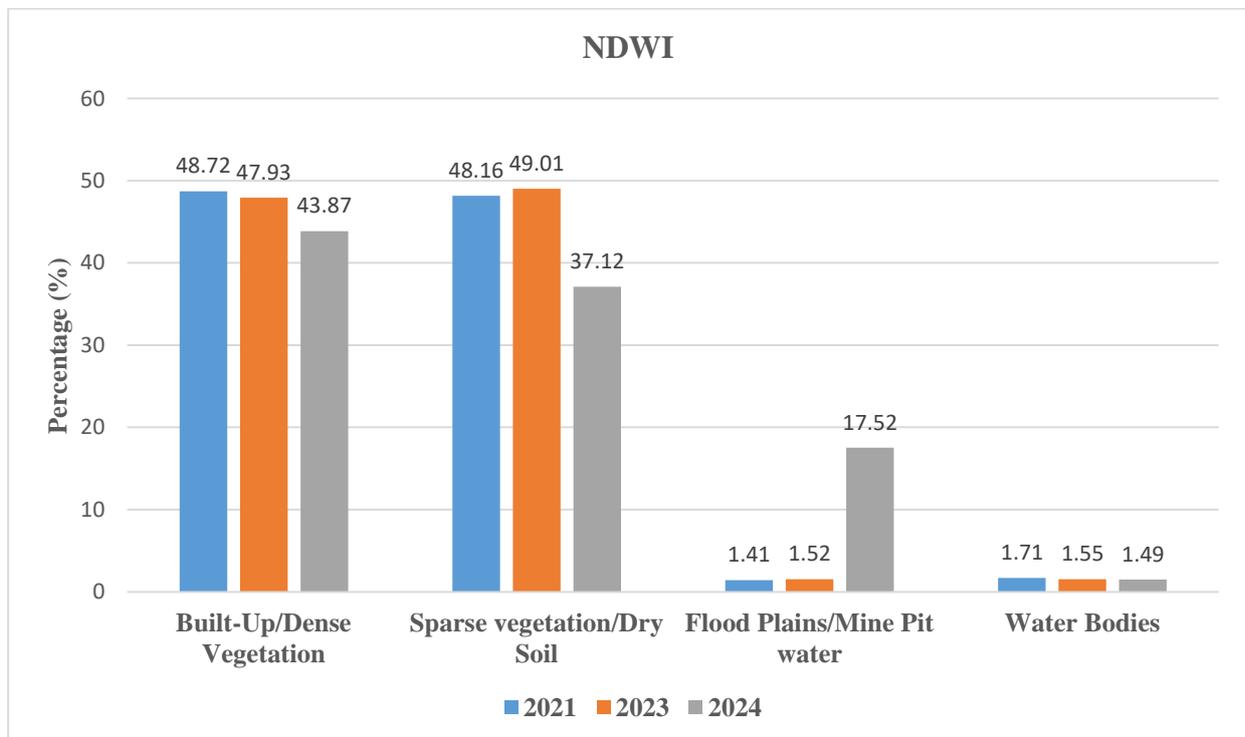
Figure 4.29: NDWI trend from 2021 to 2024
