**SPATIOTEMPORAL ANALYSIS AND
REHABILITATION OF ALLUVIAL GOLD
MINING-AFFECTED AREAS IN BETARÉ-OYA,
CAMEROON (2021-2025) USING REMOTE
SENSING**

A DISSERTATION

Presented to the
Department of Mining Engineering
Program at Selinus University

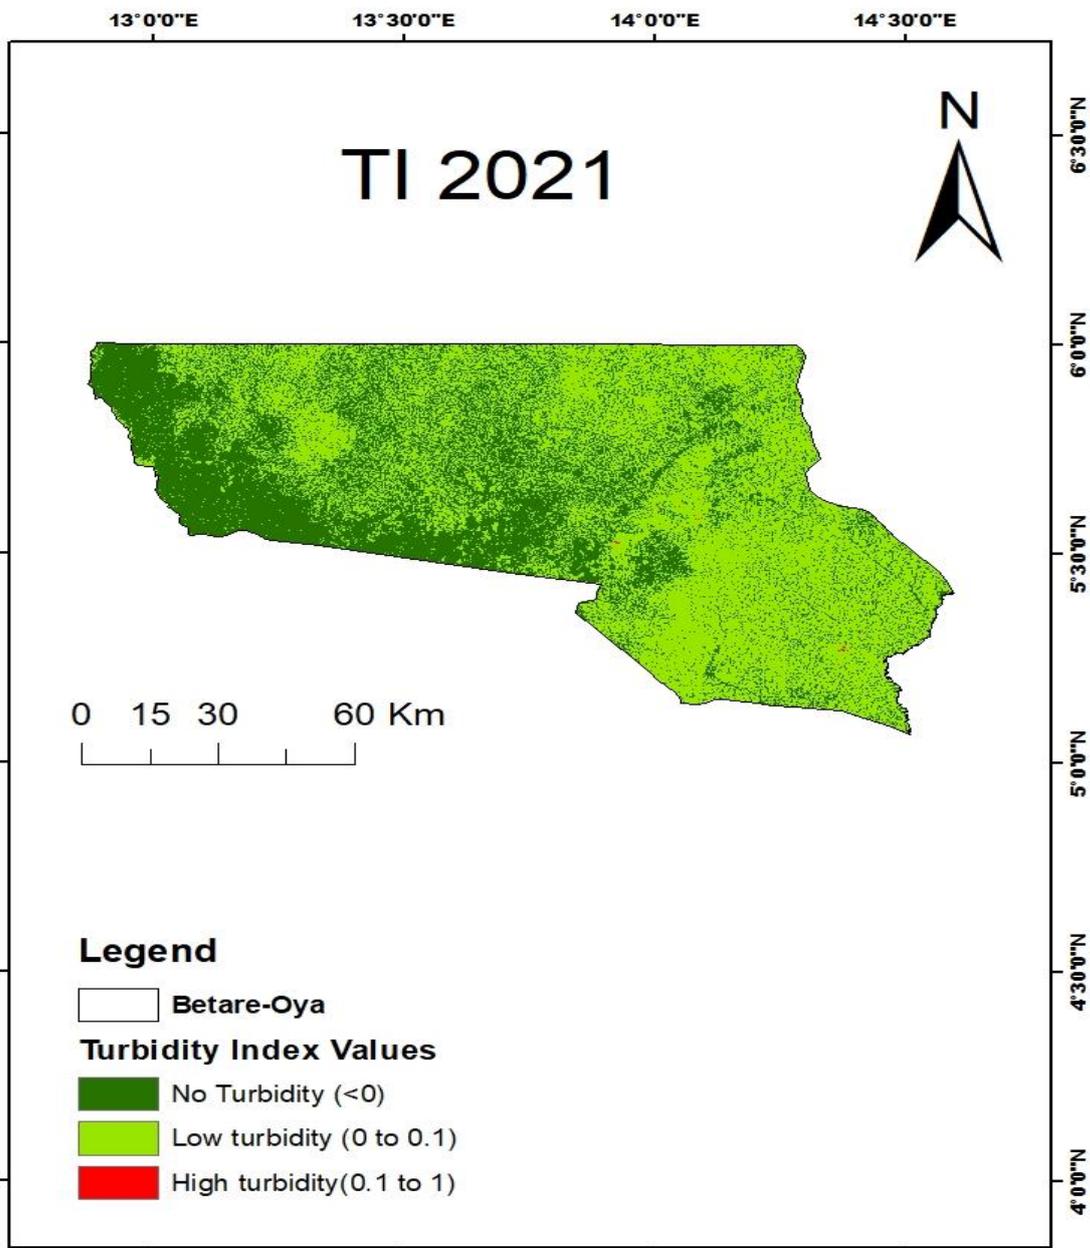
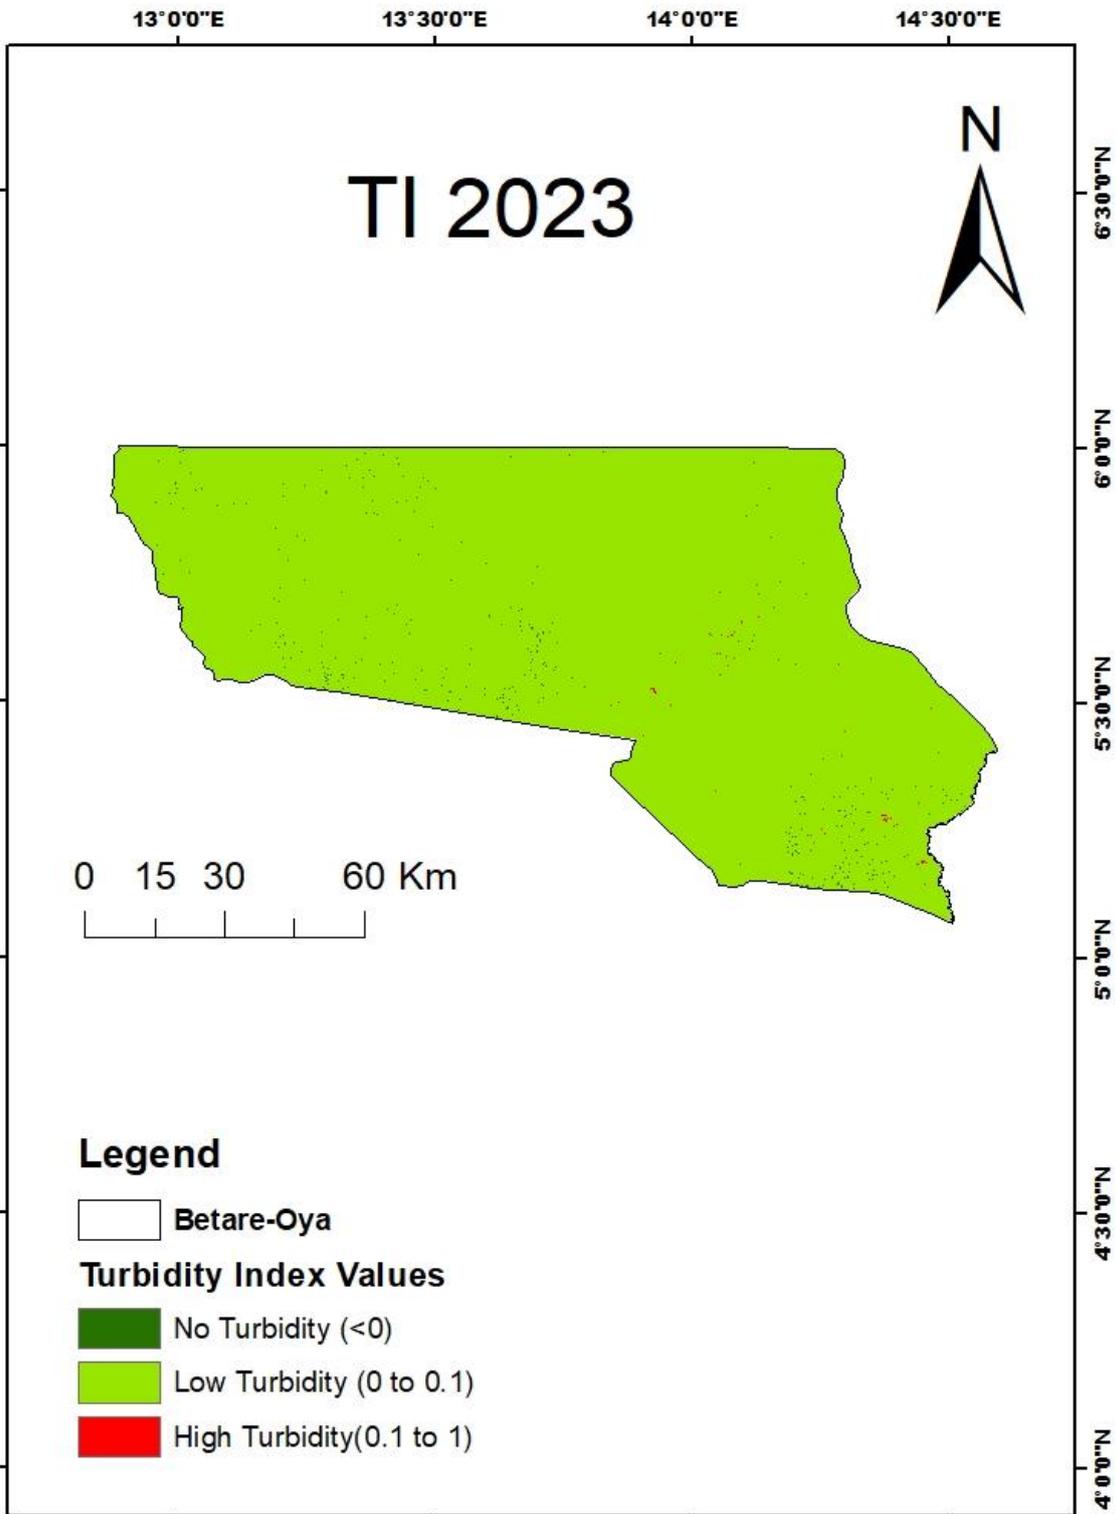
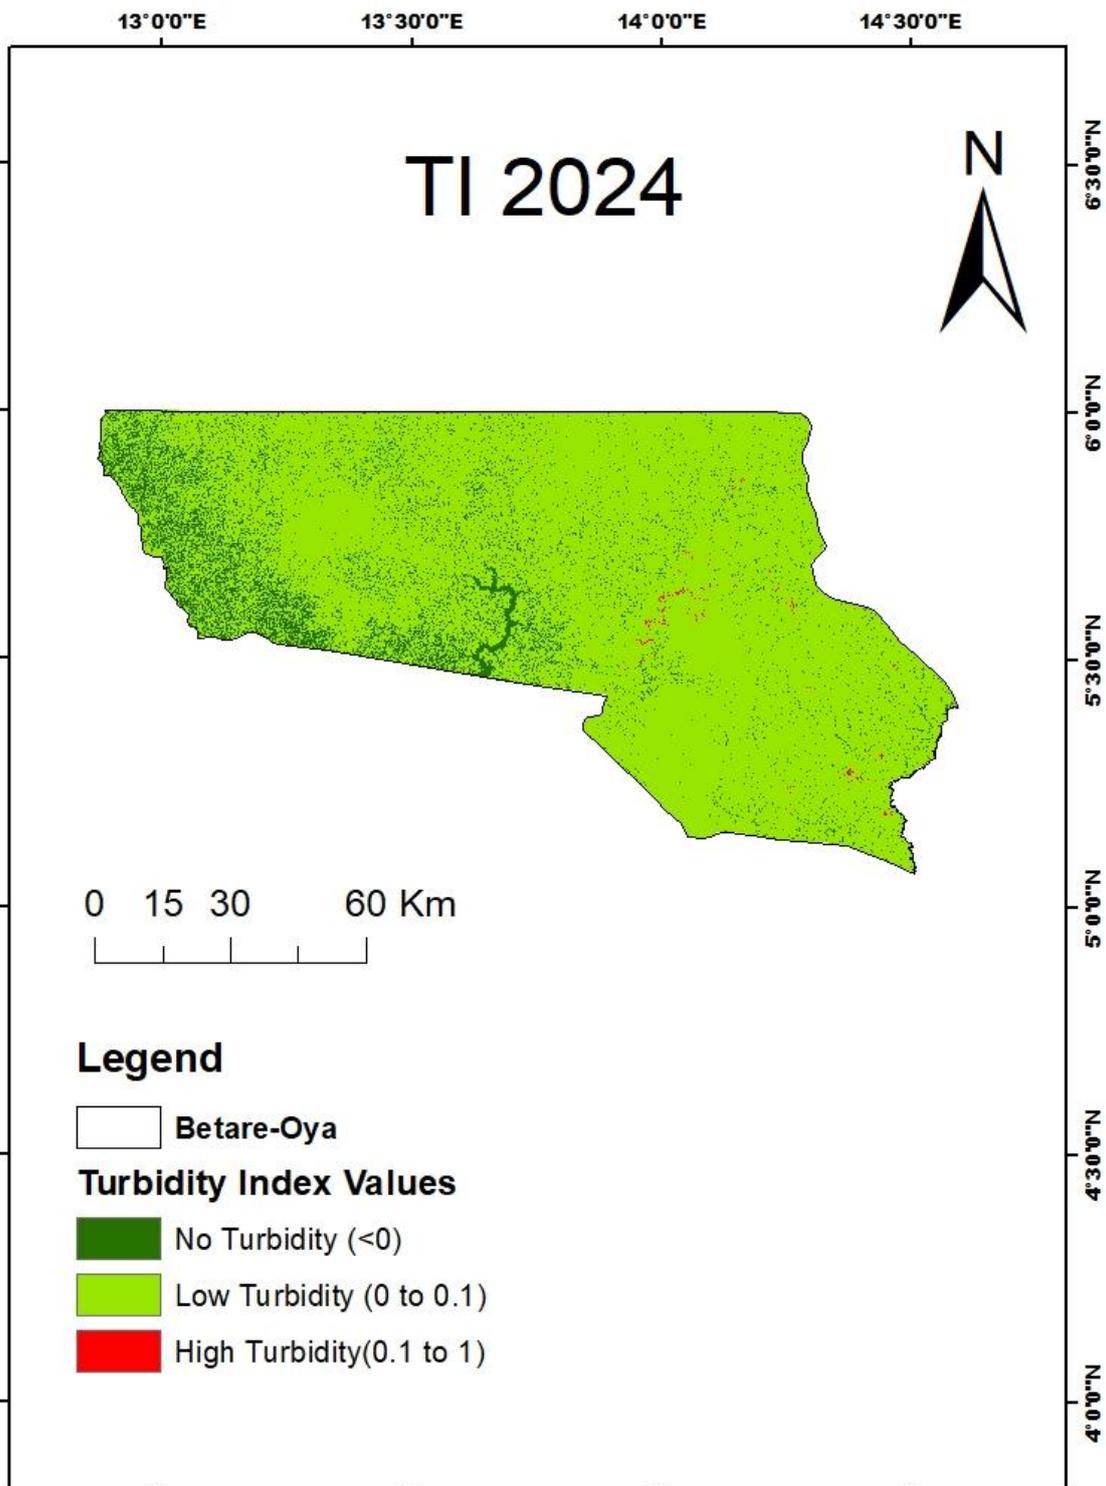
The TI maps (Figures 4.30, 4.31, and 4.32) show the spatial distribution of turbidity in the Betaré-Oya region. In 2021, the maps show a relatively low proportion of high turbidity, with most areas classified as low turbidity. However, by 2023, a noticeable increase in low turbidity is evident (99.59%). However in 2024, there is slight decrease for low turbidity (88.09%).

Figure 4.30: TI for 2021

Figure 4.31: TI for 2023

Figure 4.32: TI for 2024

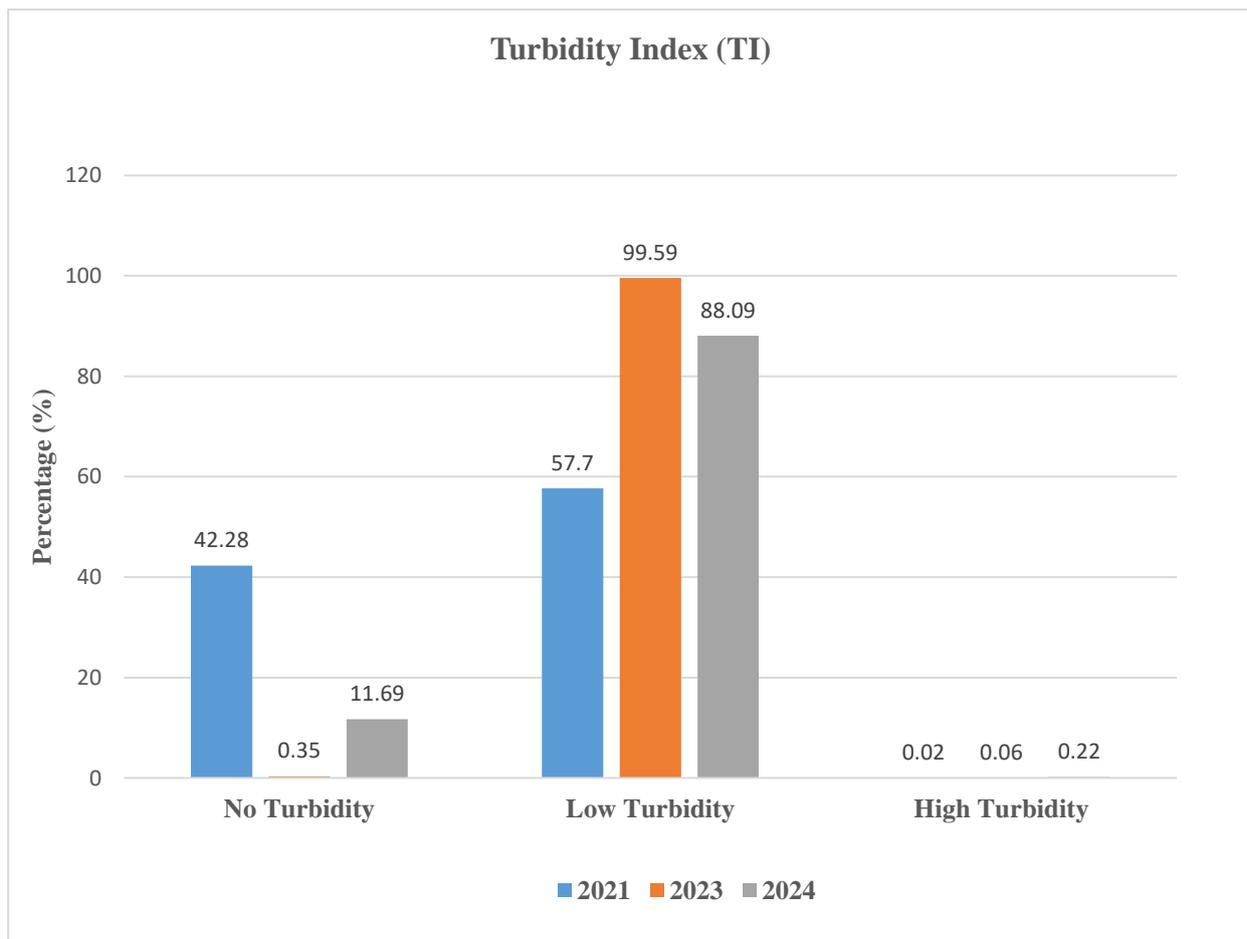
Figure 4.33: TI from 2021 to 2024

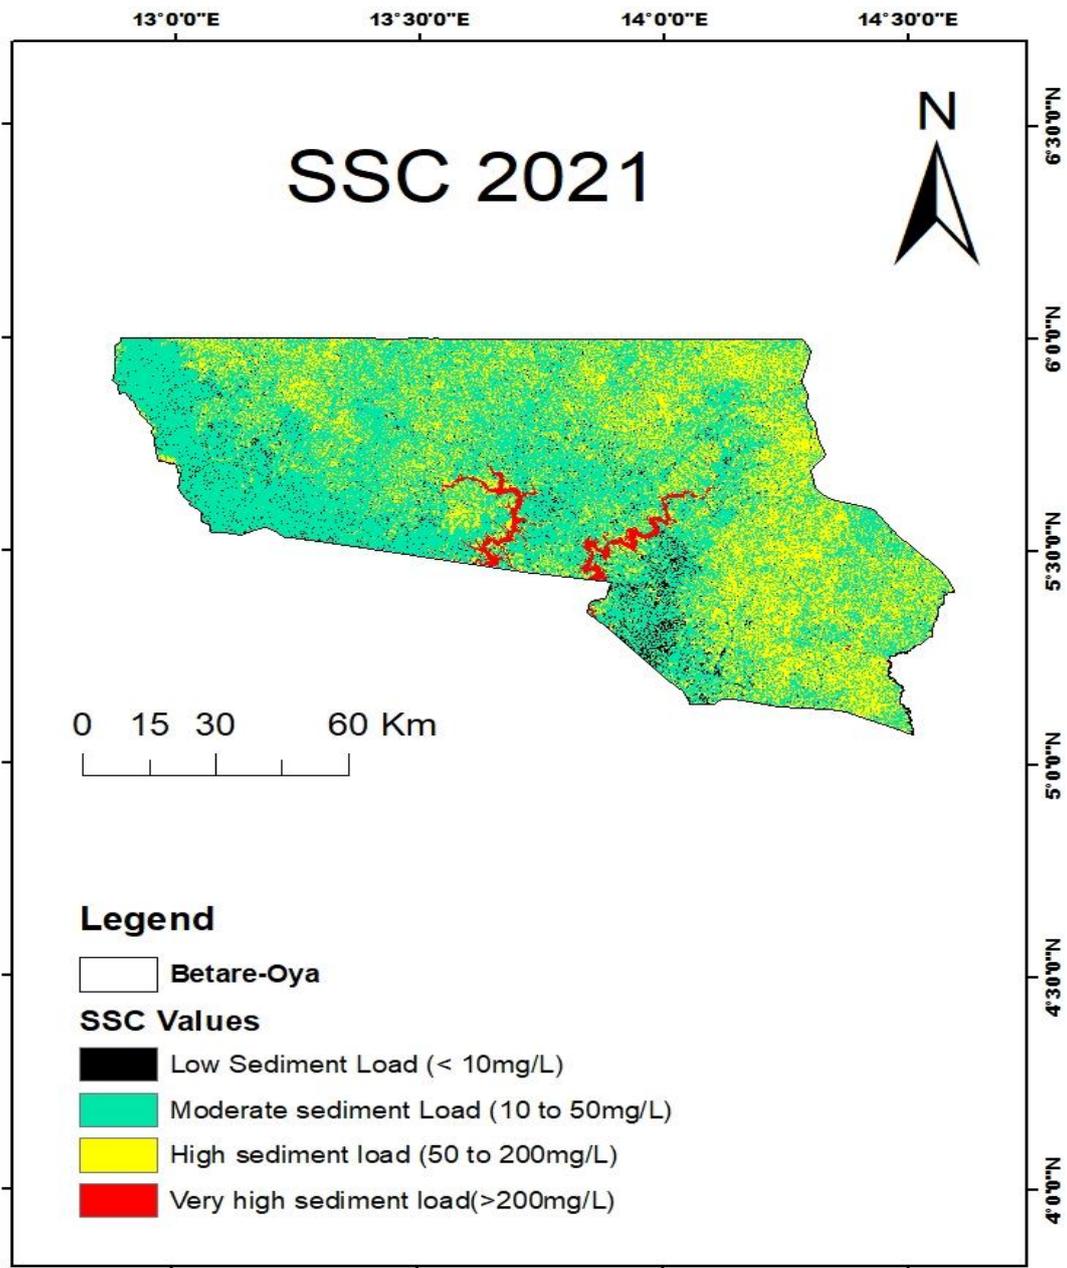
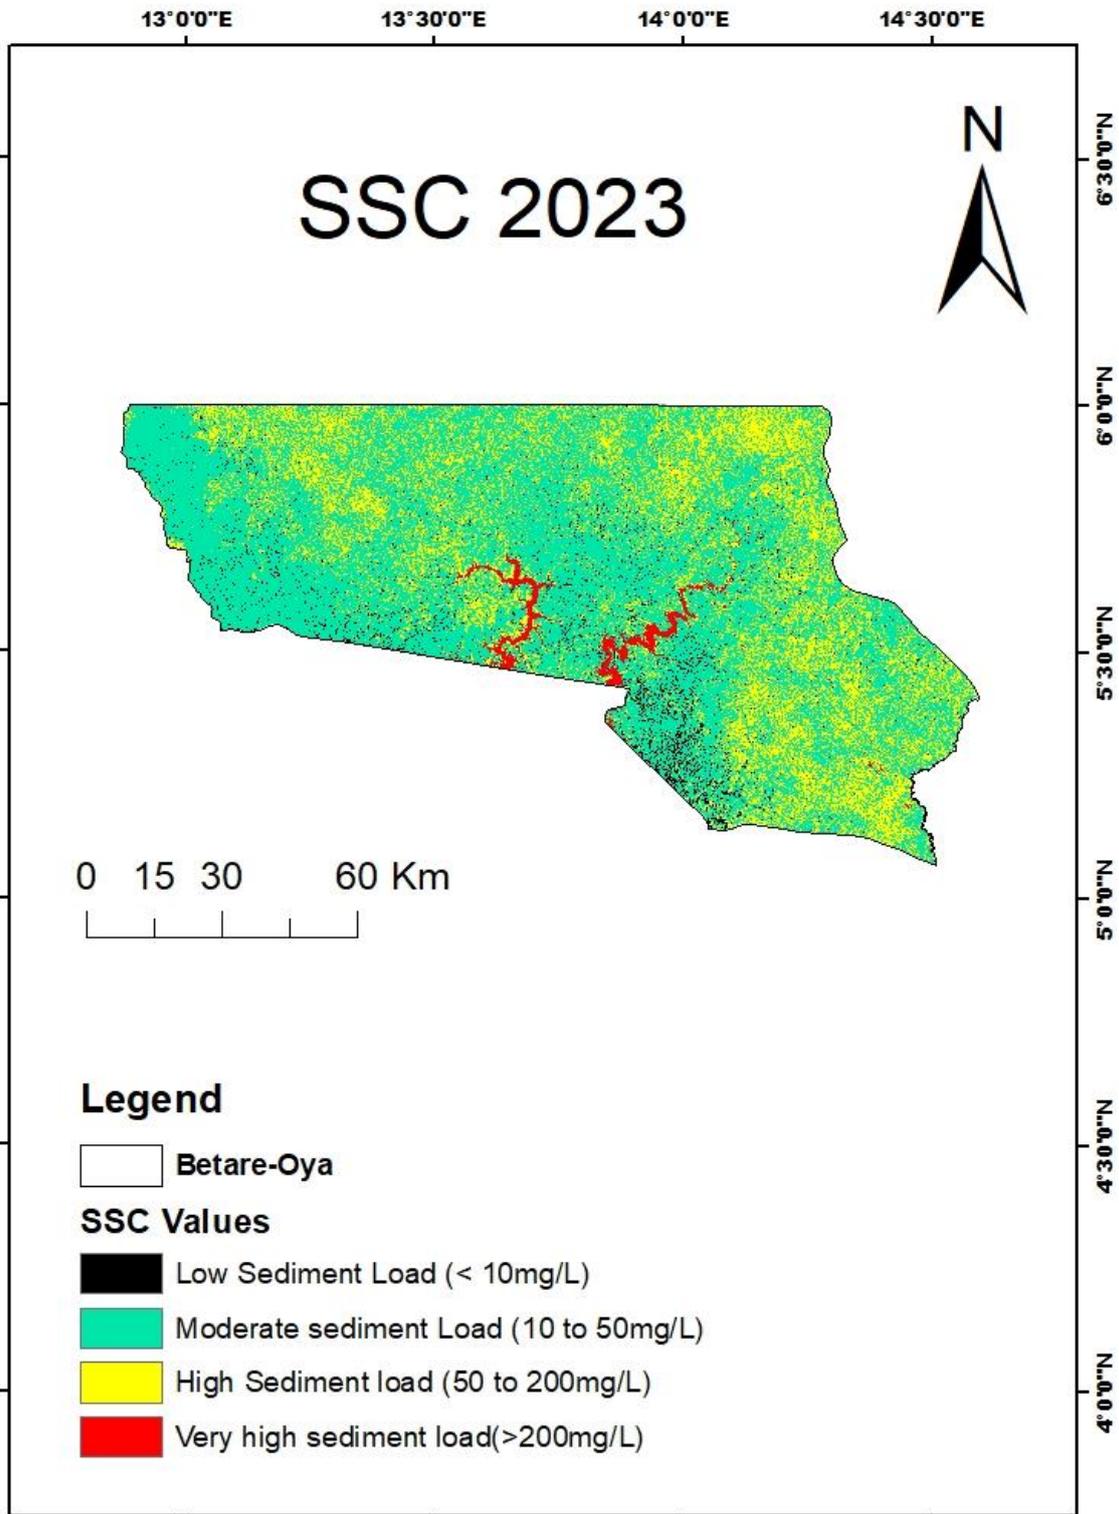
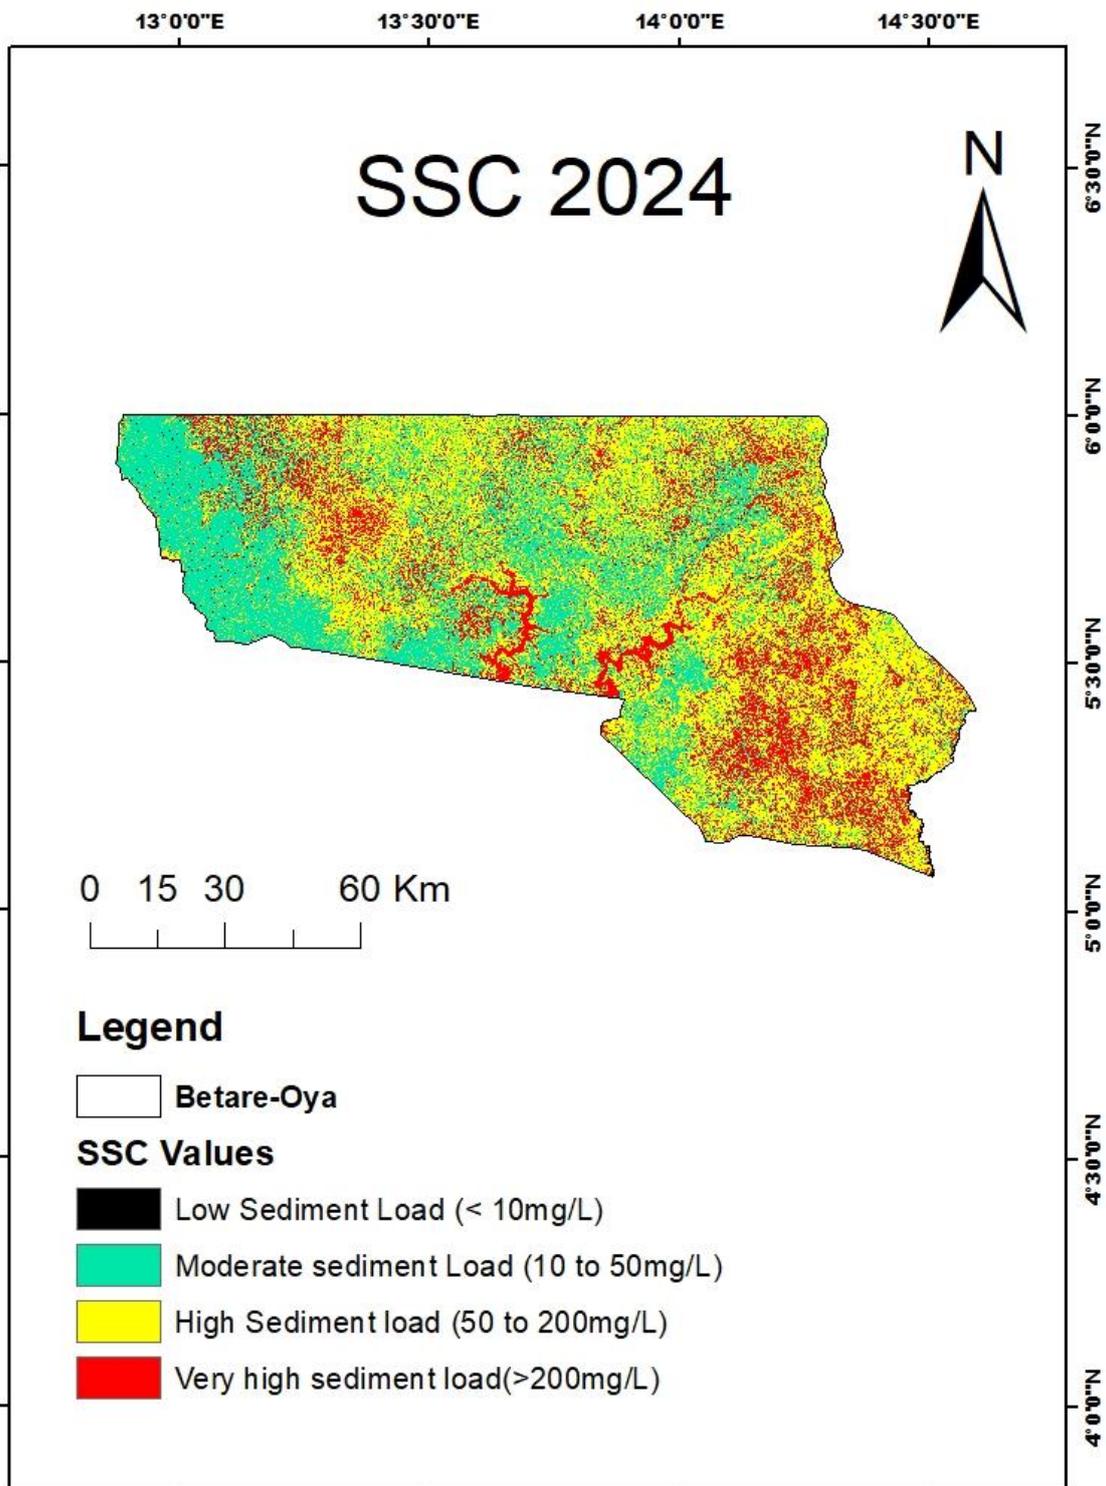
The SSC maps (Figures 4.34, 4.35, and 4.36) show the spatial distribution of suspended sediment concentration in the Betaré-Oya region. In 2021, the maps show a relatively low proportion of very high sediment (1.81%), with most areas classified as moderate sediment load. However, by 2023, there was no change for very high sediment load (1.81%). This trend continues in 2024, with further expansion of very high sediment load (20.50%).

Figure 4.34: SSC for 2021

Figure 4.35: SSC for 2023

Figure 4.36: SSC for 2024

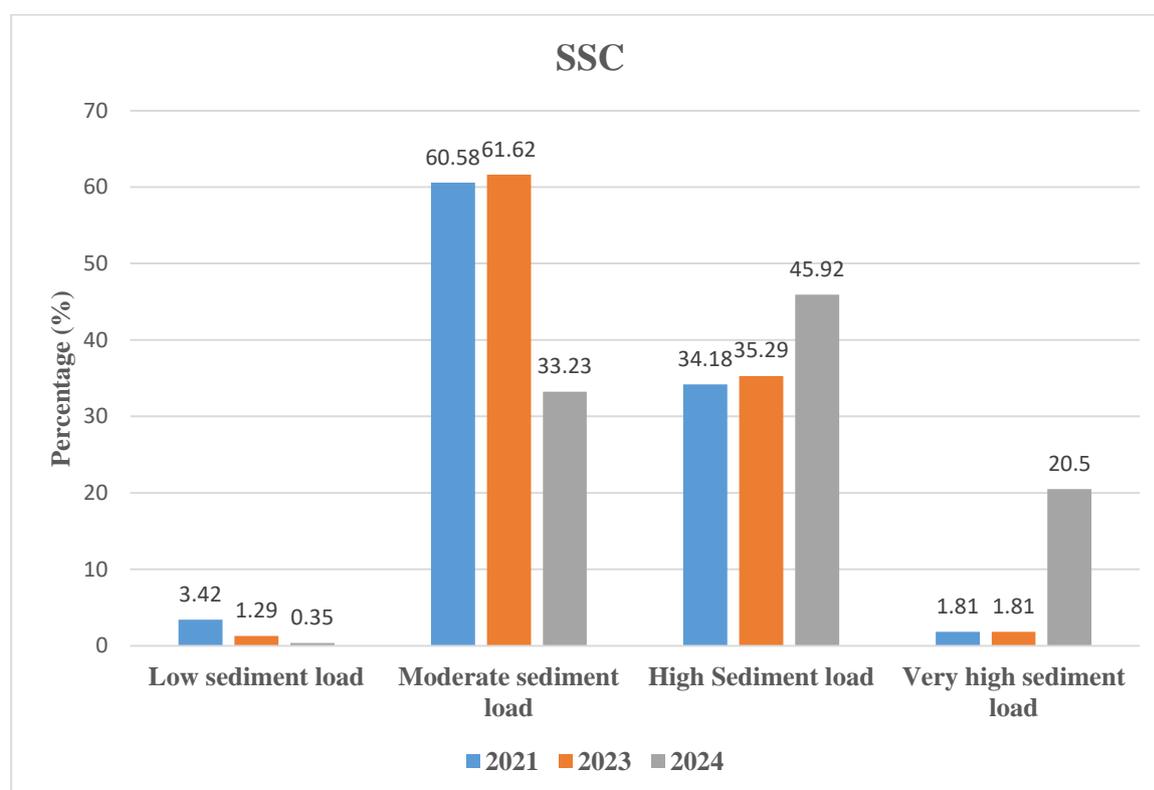
Figure 4.37: SSC from 2021 to 2024

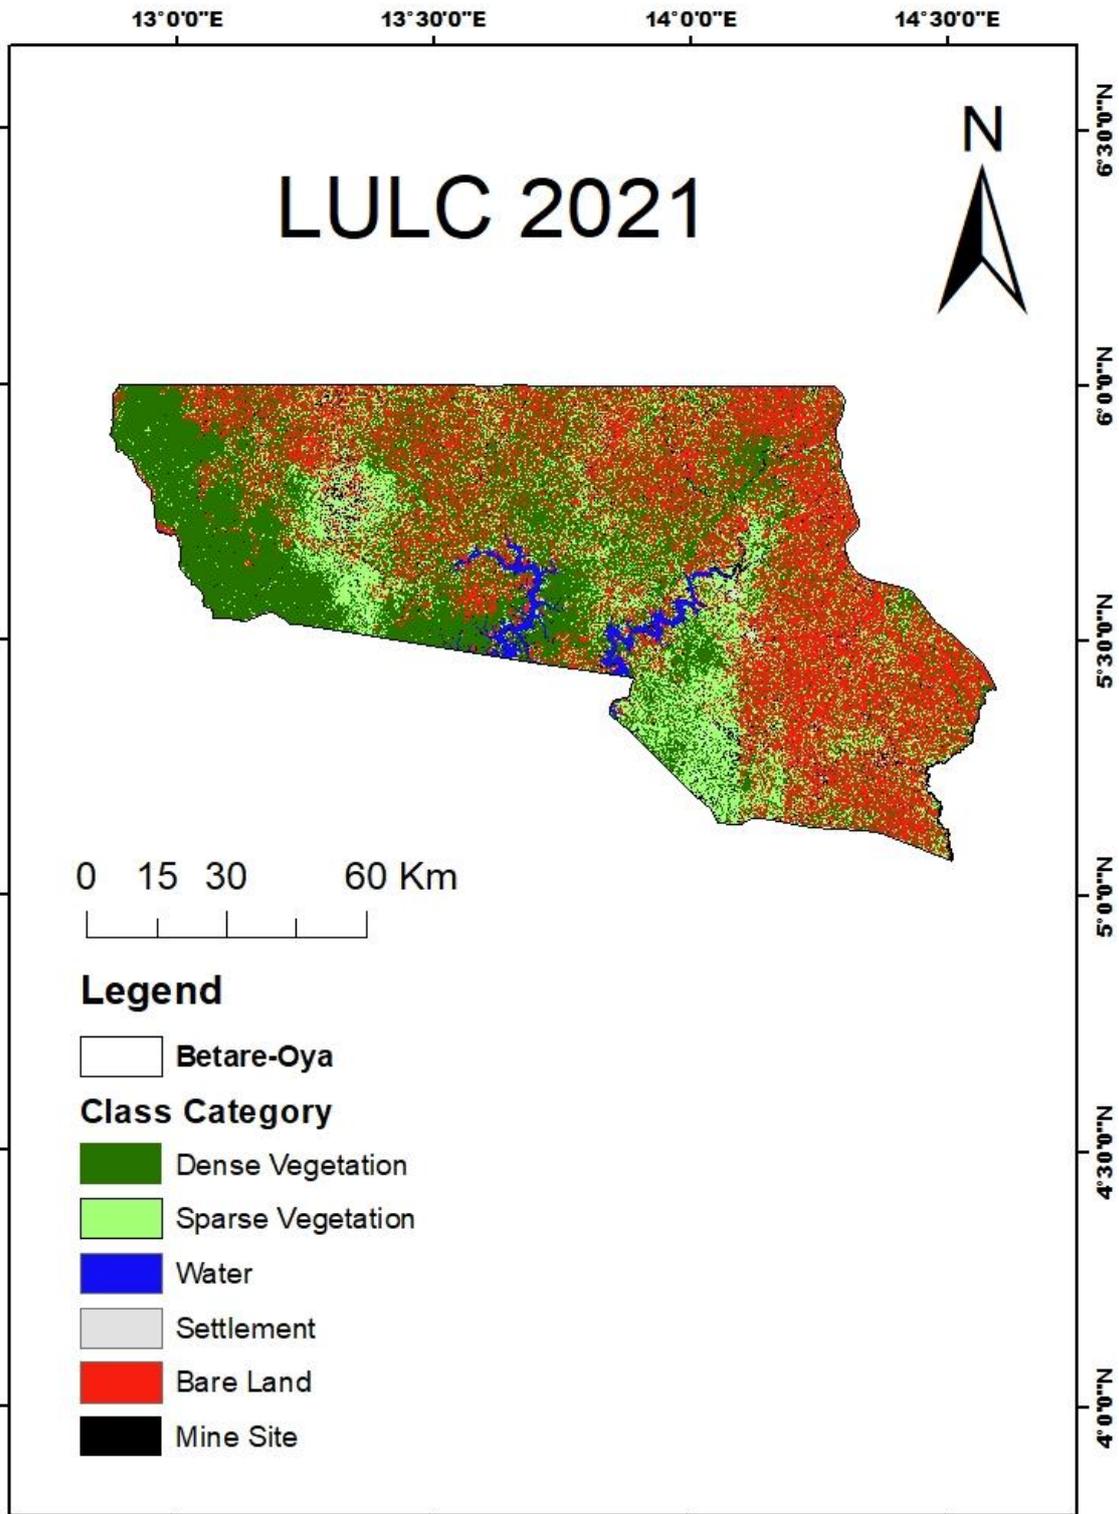
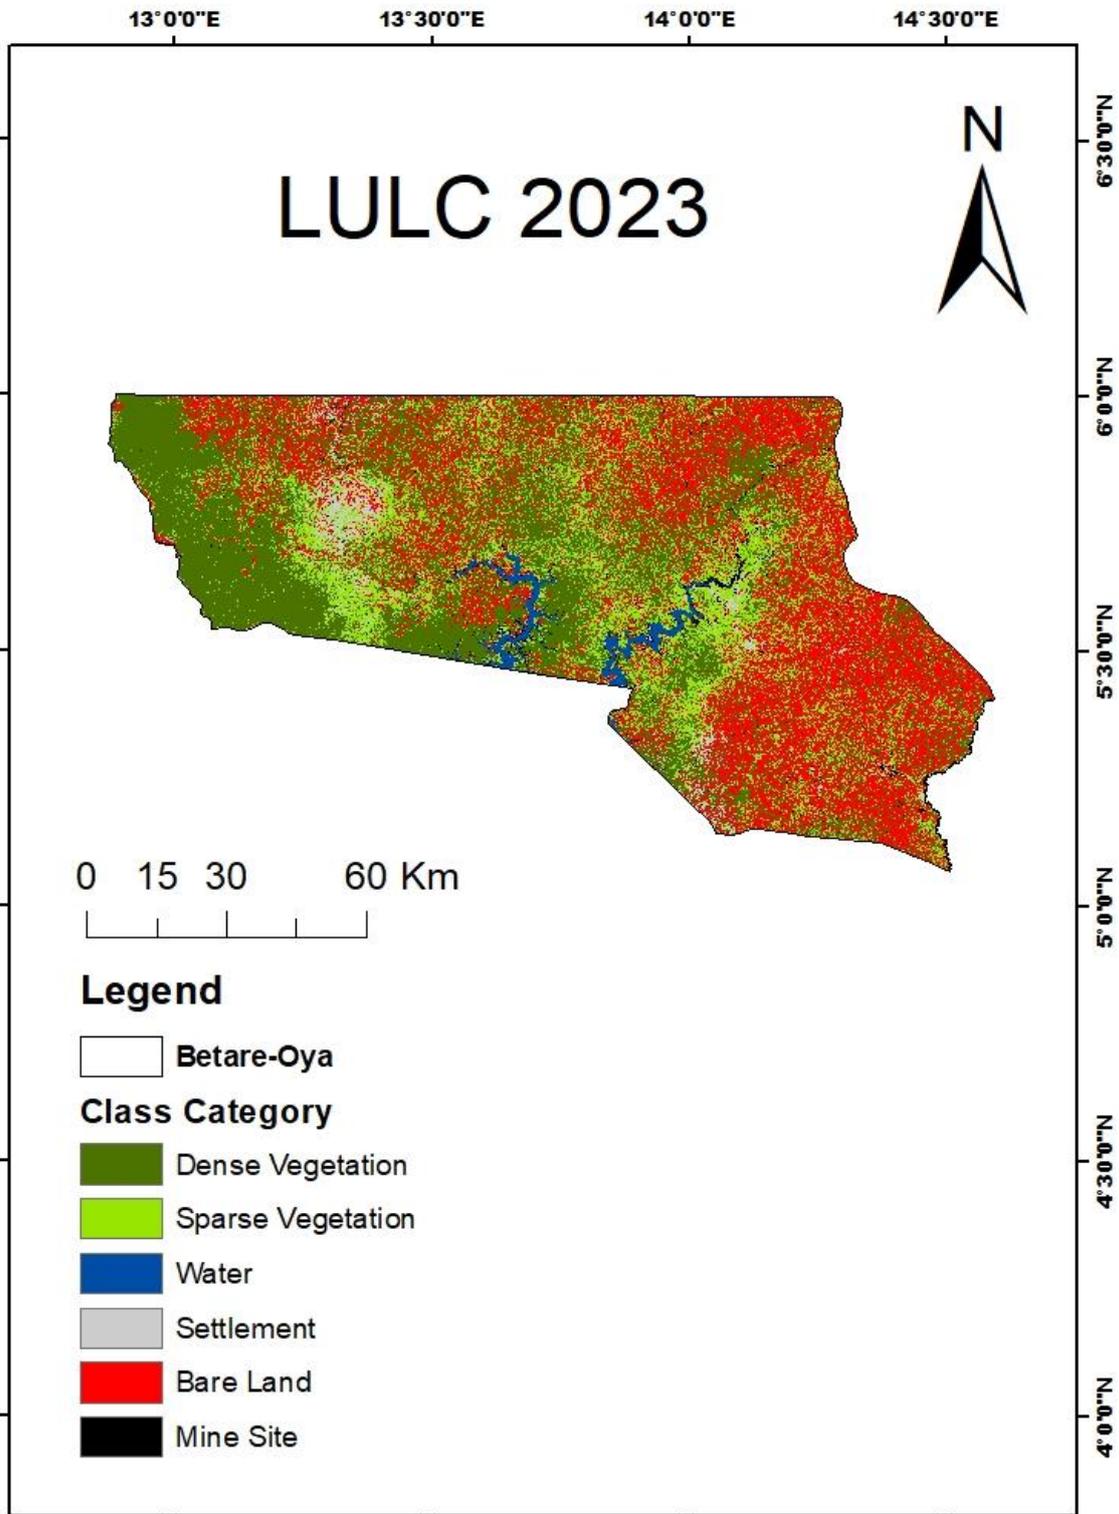
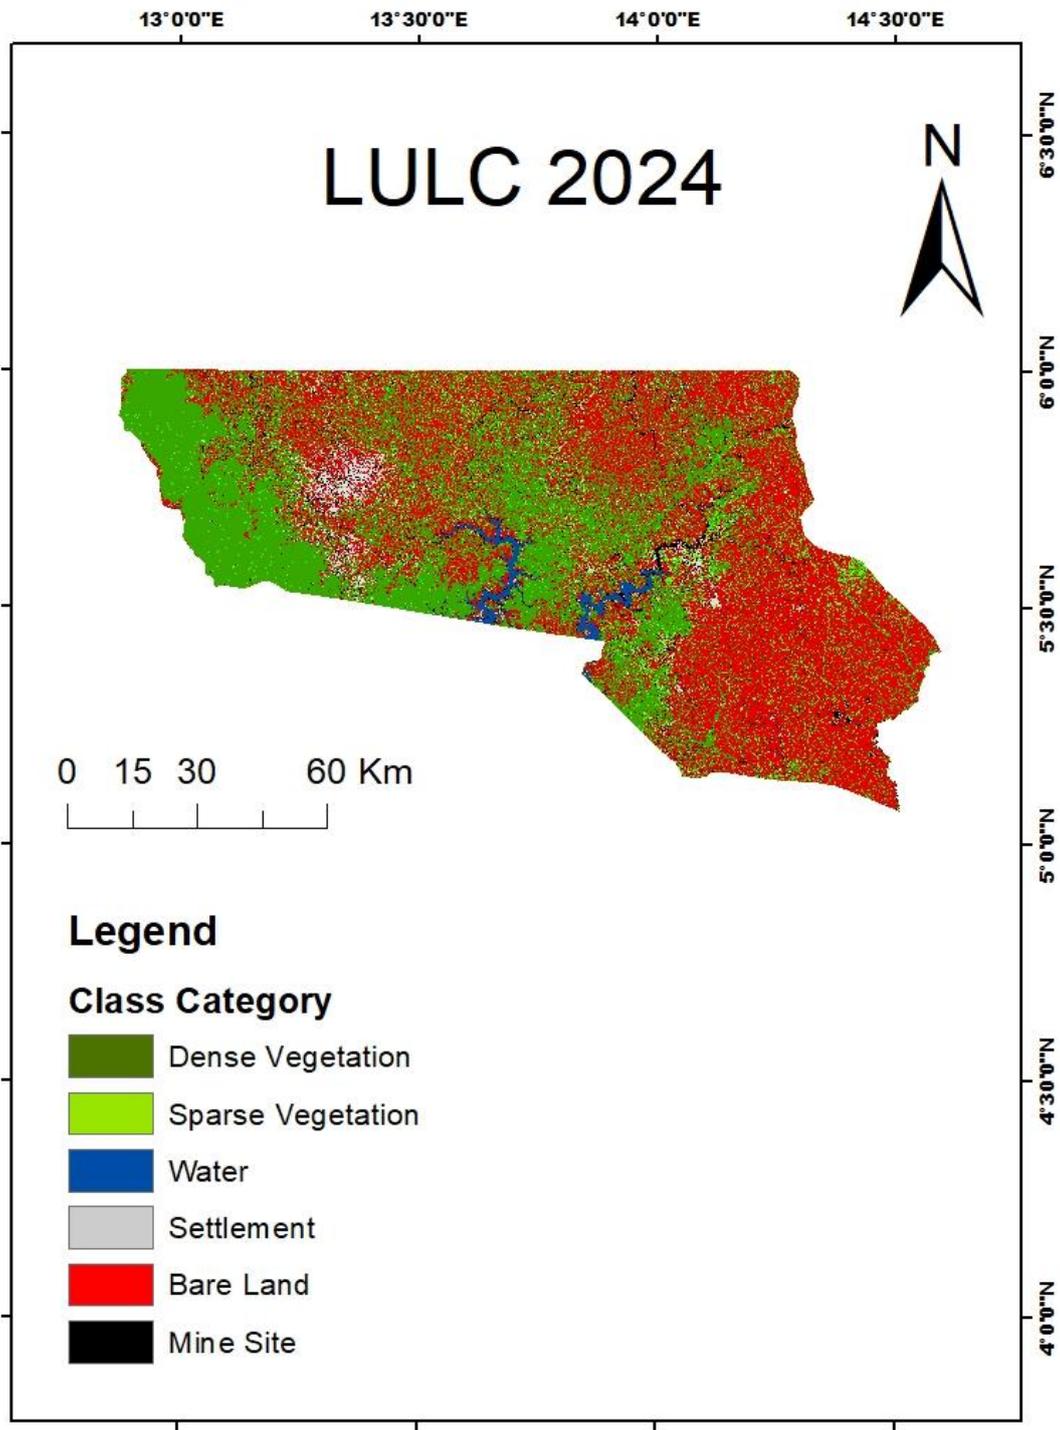
The LULC statistics (Table 4.7) provide a quantitative assessment of LULC changes. The area of dense vegetation decreased from 38.27% in 2021 to 30.69% in 2024, representing a significant loss of vegetation cover. Conversely, the area of bare land increased from 32.22% in 2021 to 45.48% in 2024, indicating a substantial increase in land degradation. The area of mine site also increased from 2.69% in 2021 to 4.76% in 2024, further confirming the expansion of mining activities.

Figure 4.38: LULC for 2021

Figure 4.39: LULC for 2023

Figure 4.40: LULC for 2024

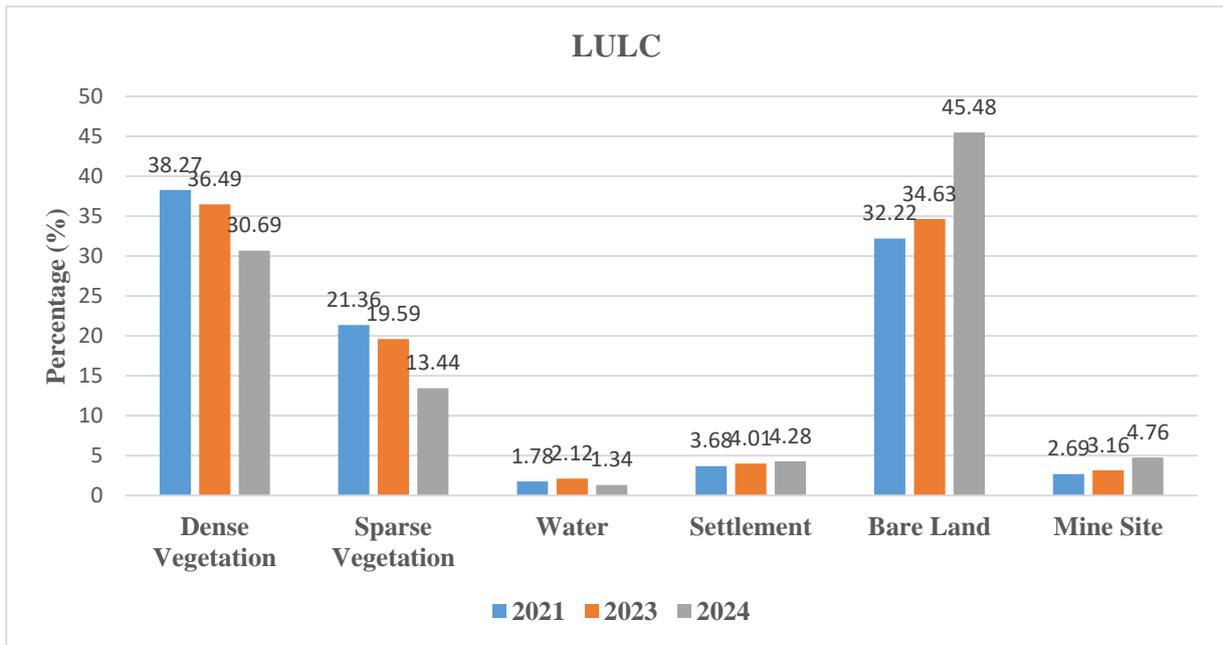
Figure 4.41: LULC from 2021 to 2024

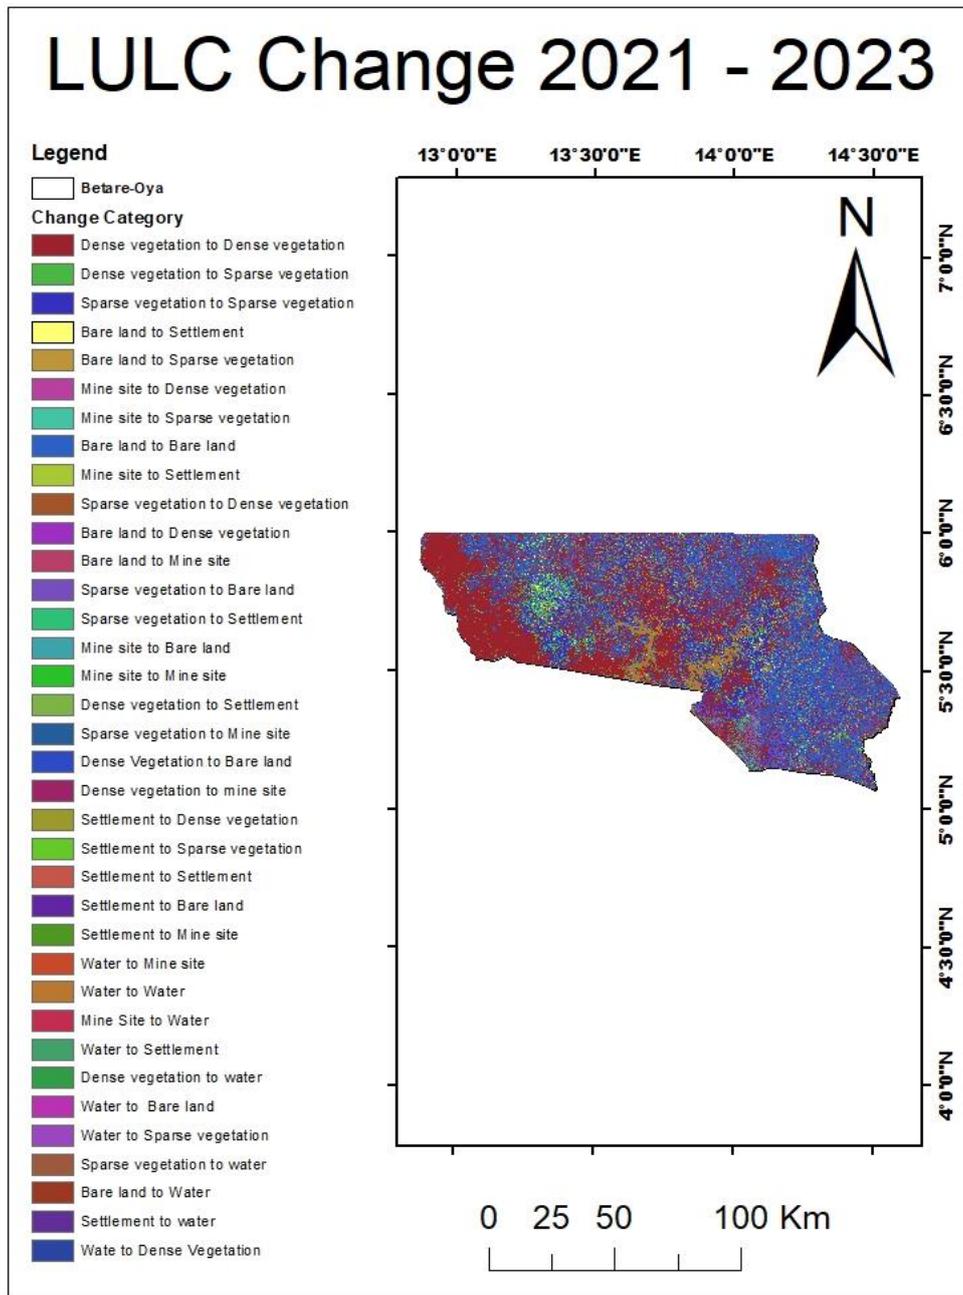
Figure 4.42: LULC Change detection from 2021 to 2023

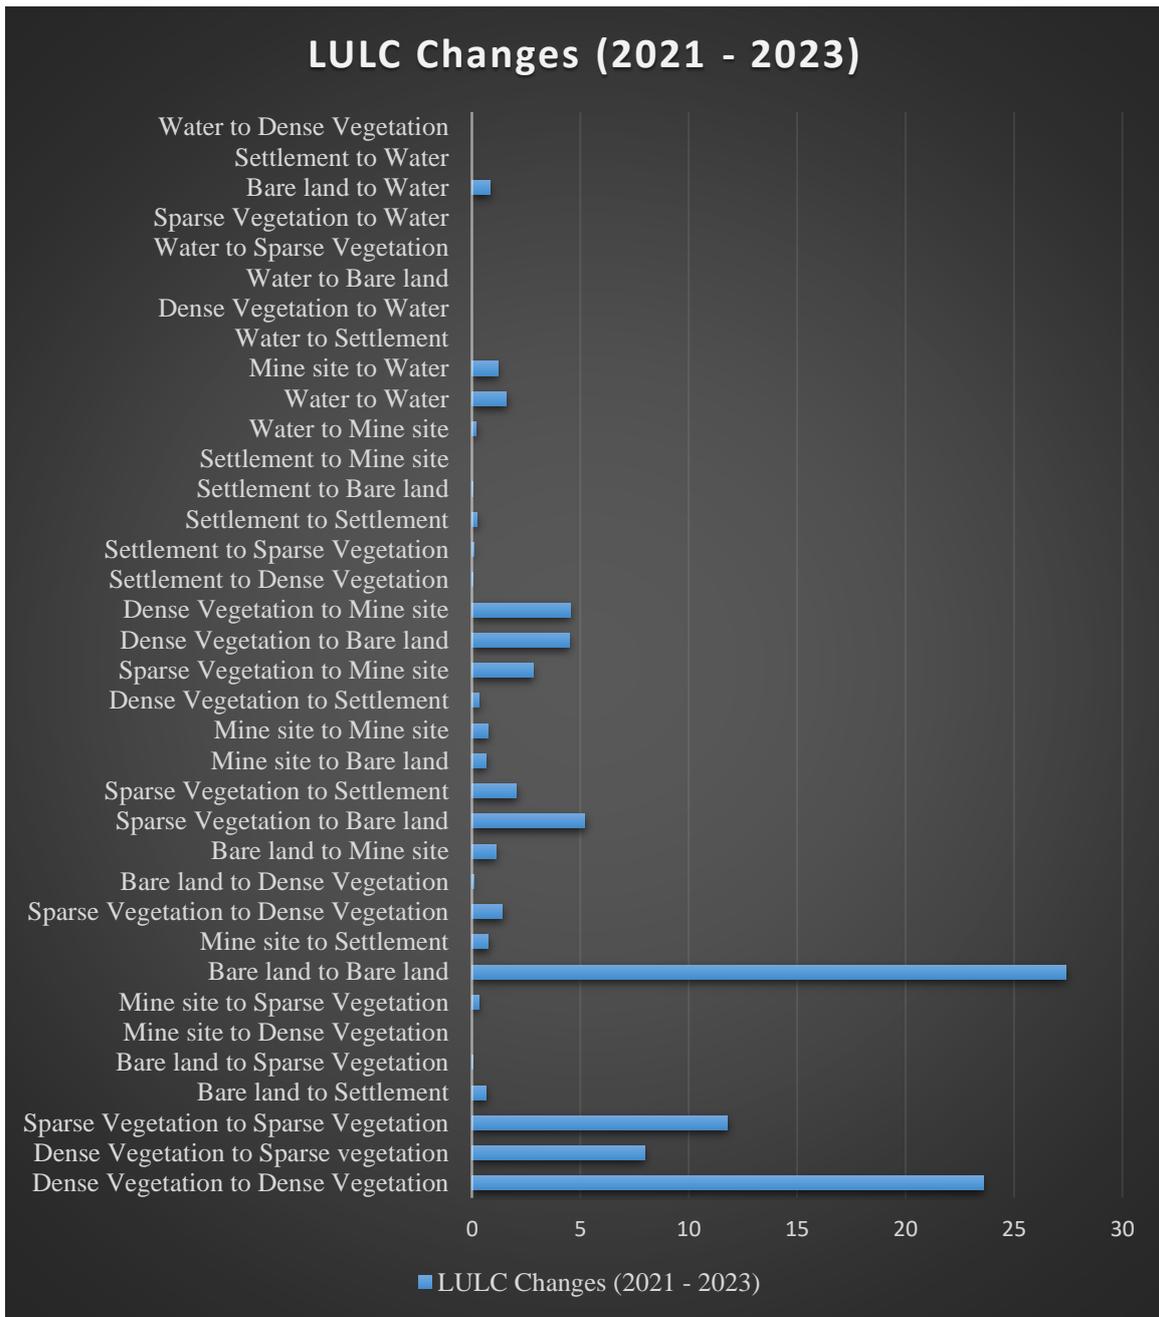
Figure 4.43: LULC Change detection histogram from 2021 to 2023

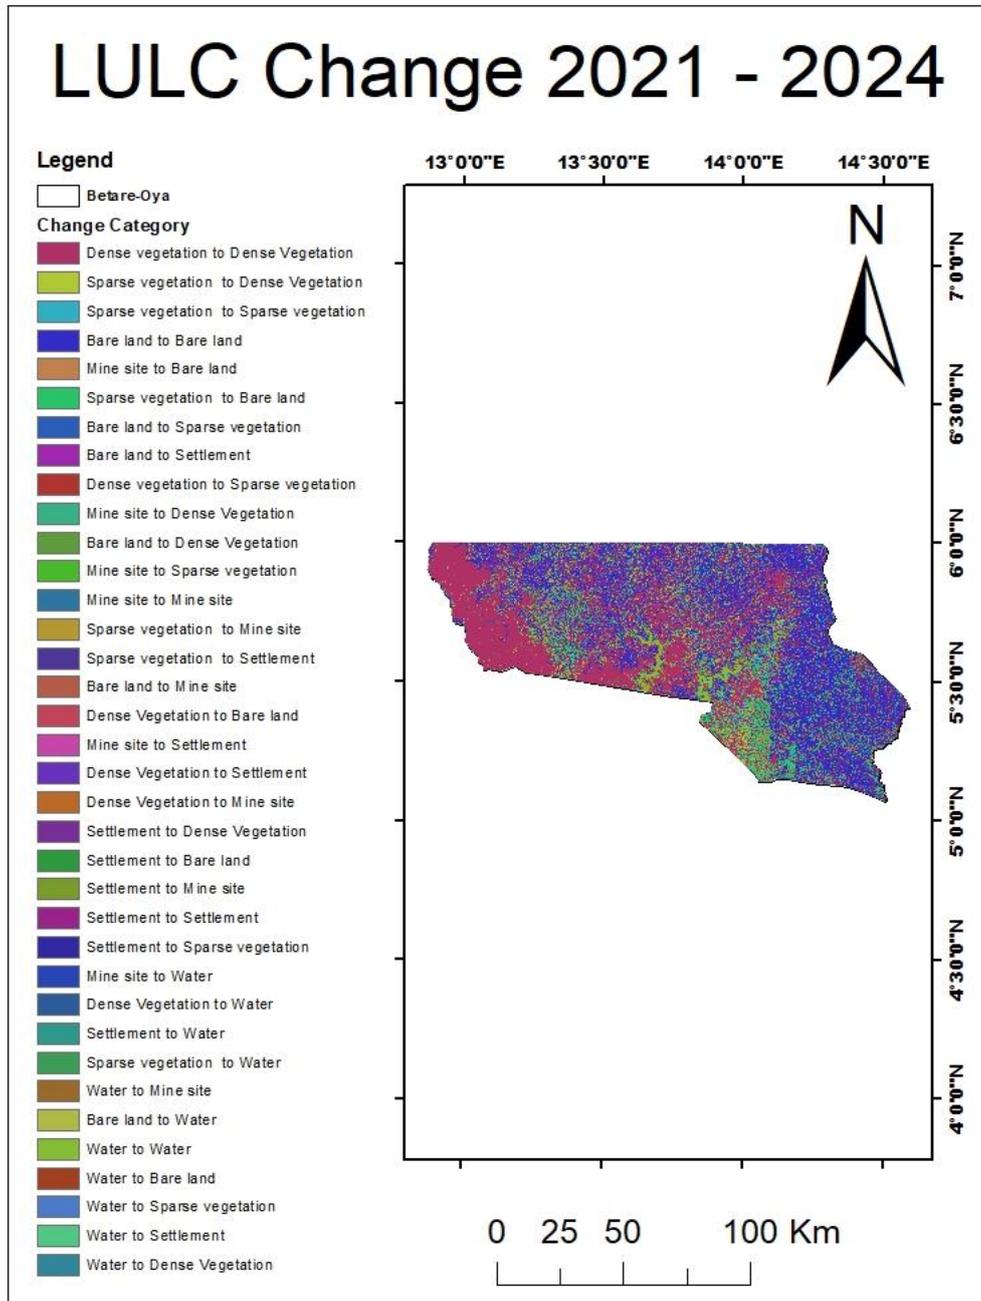
Figure 4.44: LULC Change detection from 2021 to 2024
