**SPATIOTEMPORAL ANALYSIS AND
REHABILITATION OF ALLUVIAL GOLD
MINING-AFFECTED AREAS IN BETARÉ-OYA,
CAMEROON (2021-2025) USING REMOTE
SENSING**

A DISSERTATION

Presented to the
Department of Mining Engineering
Program at Selinus University

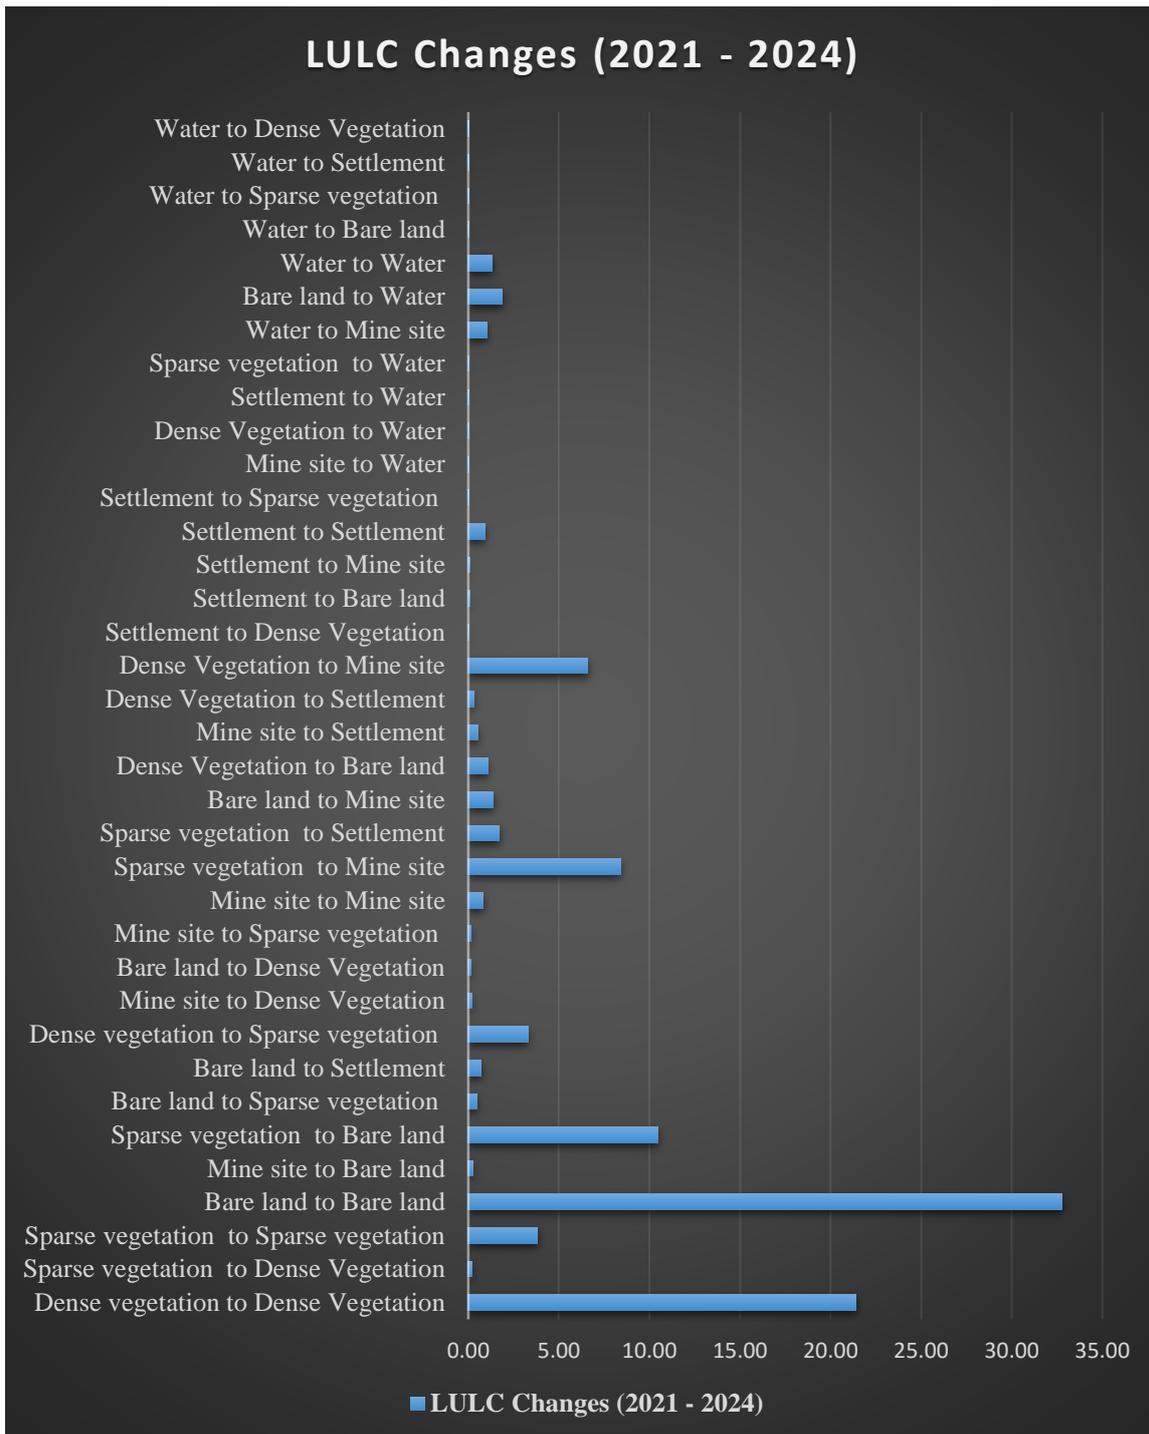
Figure 4.45: LULC Change detection histogram from 2021 to 2024
